## Appendix N: LSN Examples

## **N1 Introduction**

## **Typical Photographs of LSN Ranges**

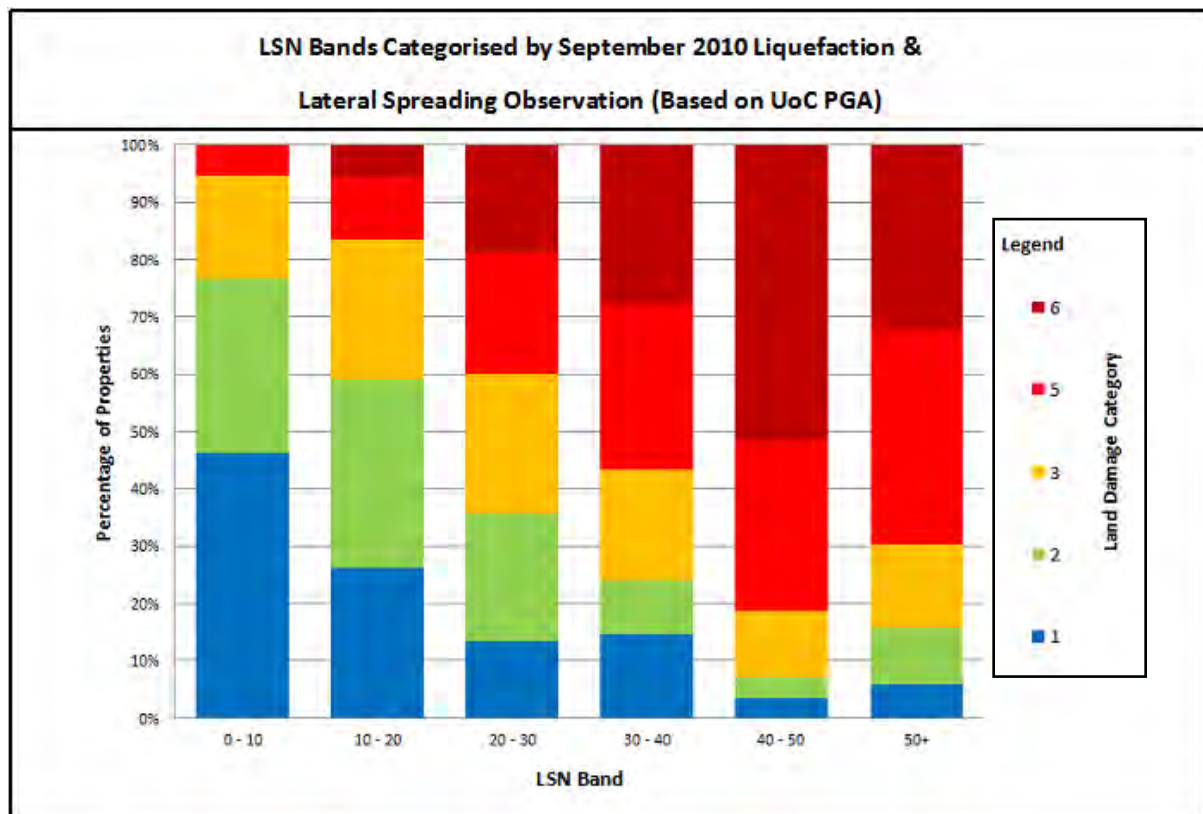
Figure N1 – September 2010 land observations

The figures show consistent trends for the earthquakes of an increasing severity of liquefaction and lateral spreading observations with increasing LSN. The shape of the trends with the normalised data is consistent, with very low levels of severe liquefaction induced damage at low LSN. By comparison, at high LSN there are very few sites with no to minor liquefaction induced damage. The September 2010 data has a very high proportion of no to minor liquefaction induced damage at low LSN, which is consistent with the low levels of liquefaction related damage around Canterbury.

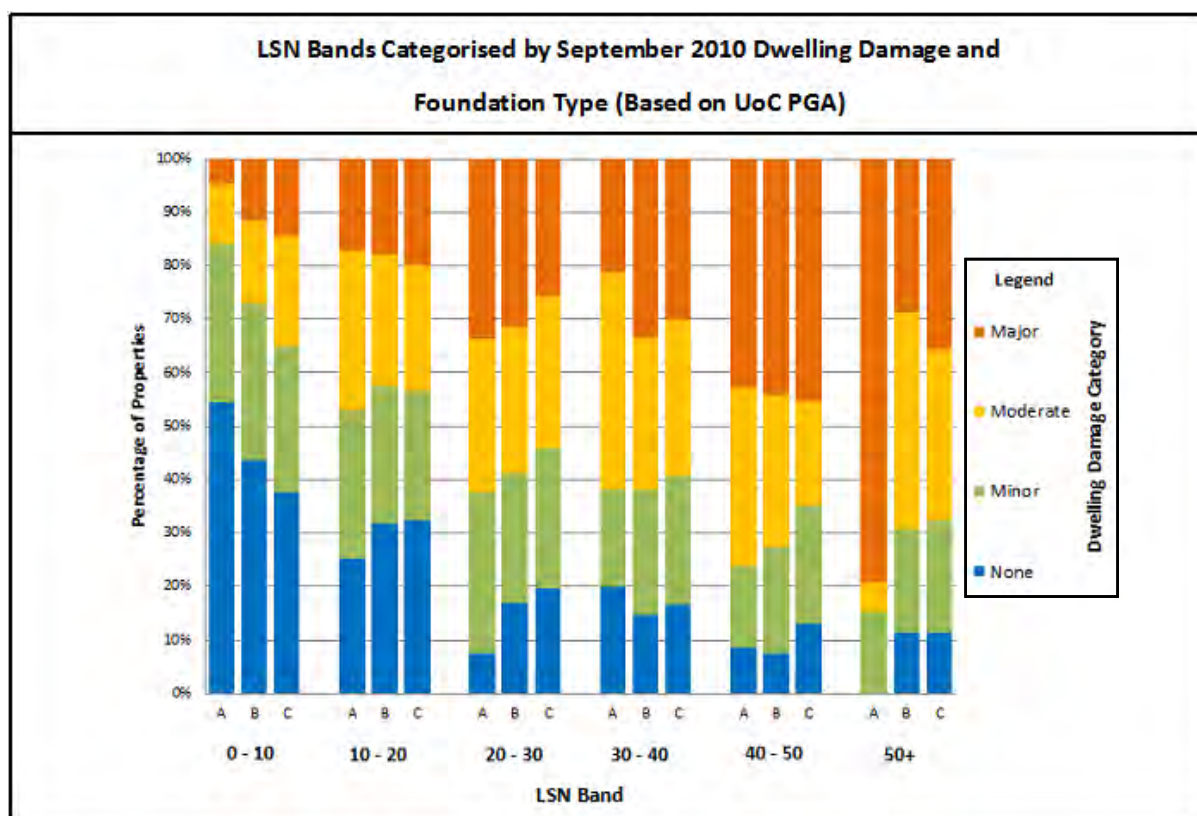
Figure N5 – September 2010 dwelling foundation damage observations

The figures show that there is a weak to moderate correlation between LSN and dwelling foundation damage. The correlation is not as strong as that between LSN and land observations.

While there are differences between the different foundation types, Figures N5 and N6 show that no foundation type performs significantly and consistently better than others.

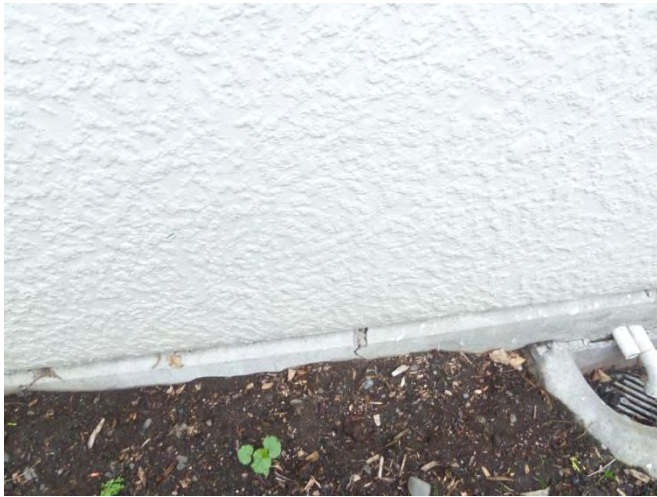
m) Foundation damage

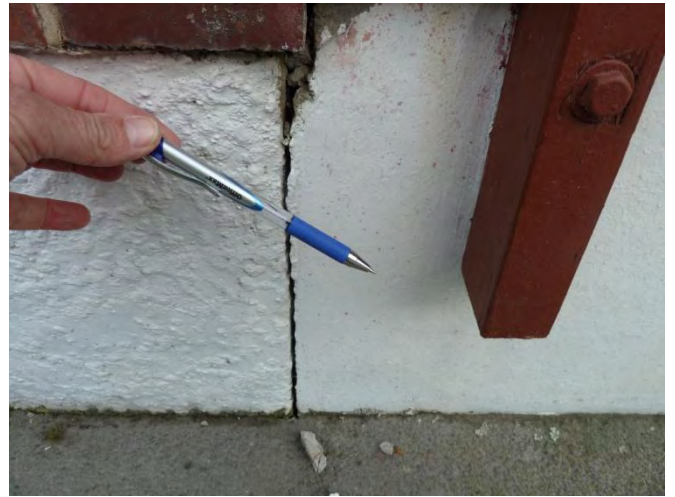
n) Foundation damage

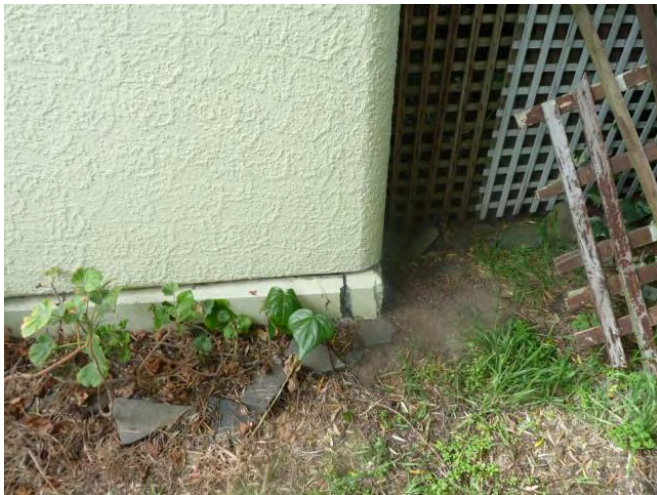
o) Foundation damage

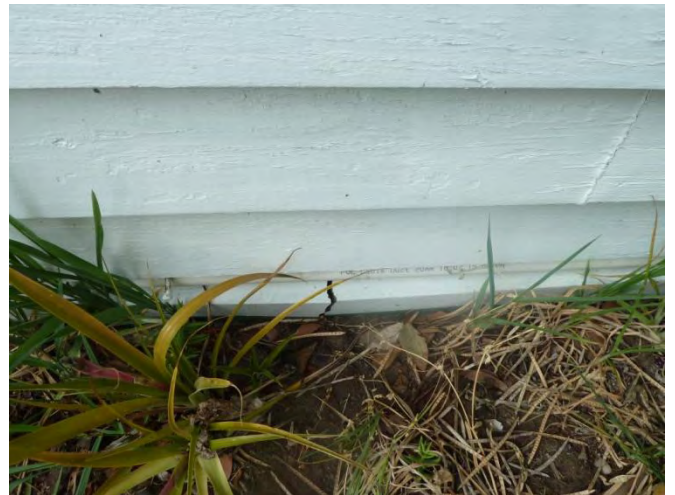
p) Foundation damage

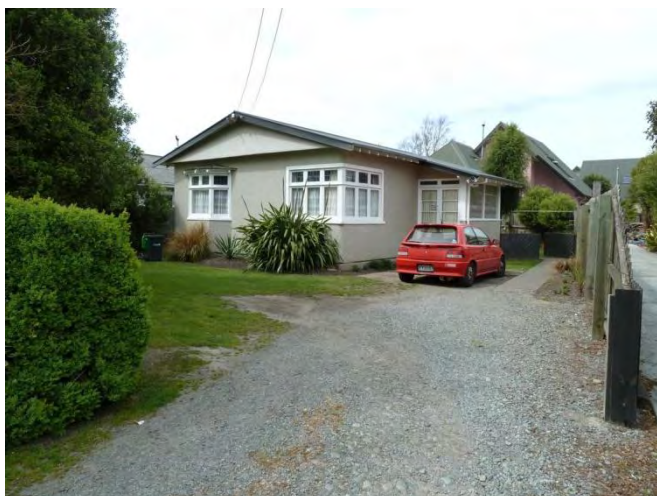
q) Undulating lawns and liquefaction ejecta

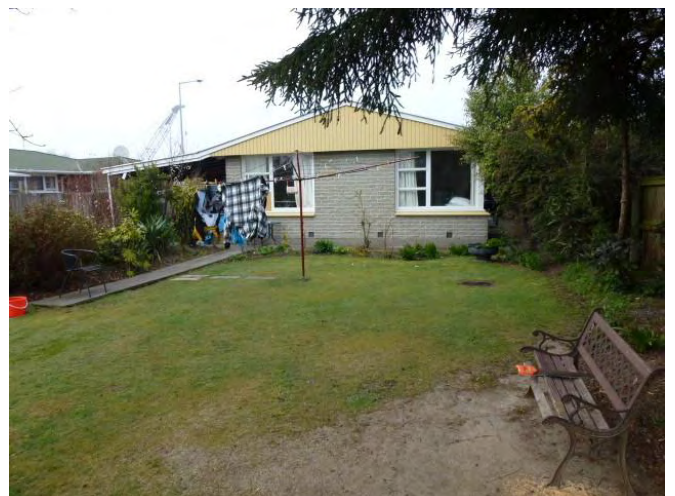
r) Liquefaction ejecta on lawn

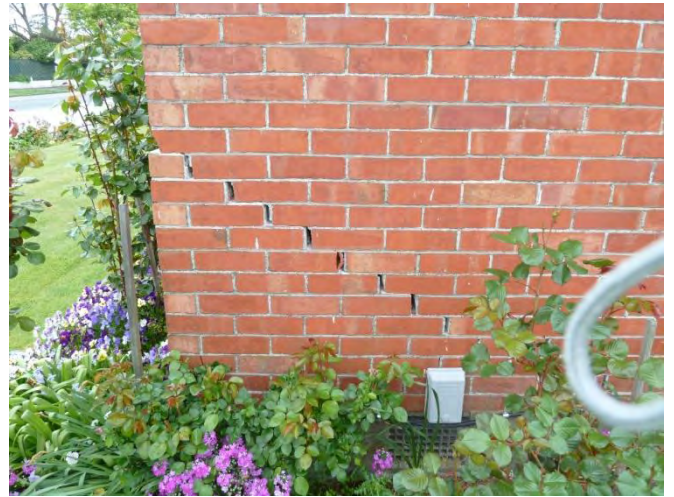
t) Damage to brickwork

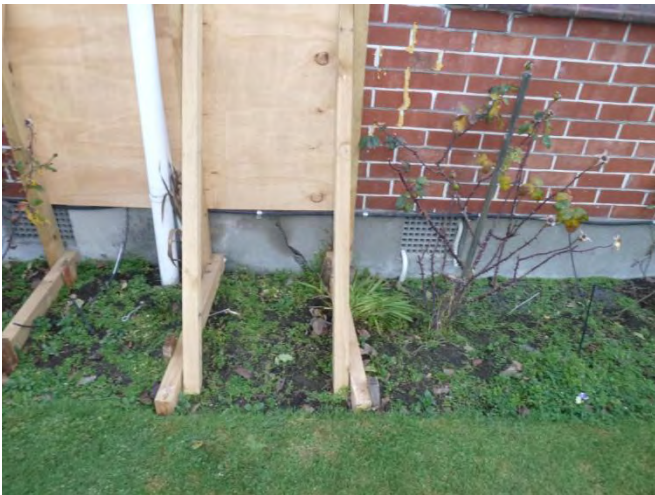
u) Foundation damage

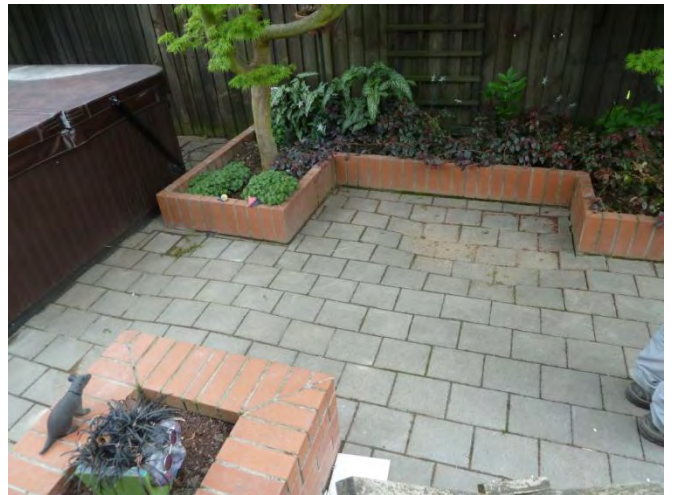
v) Undulating paving slabs

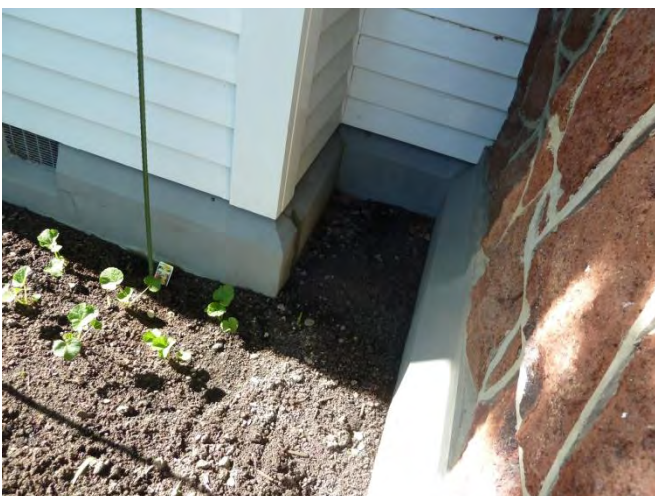
w) Foundation damage

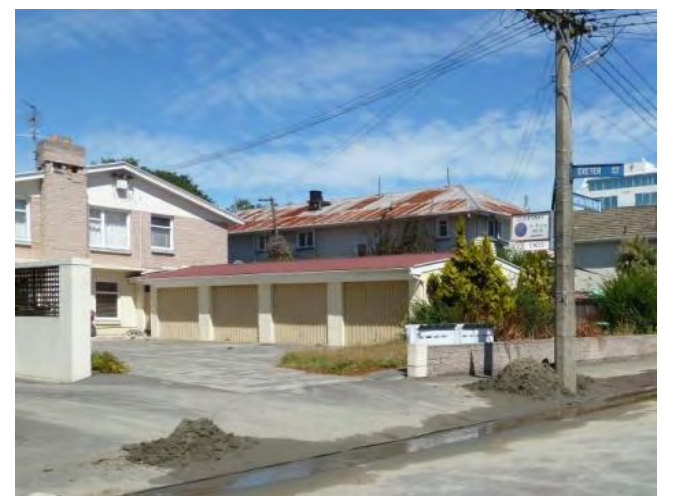
x) Piles of sand along the footpath

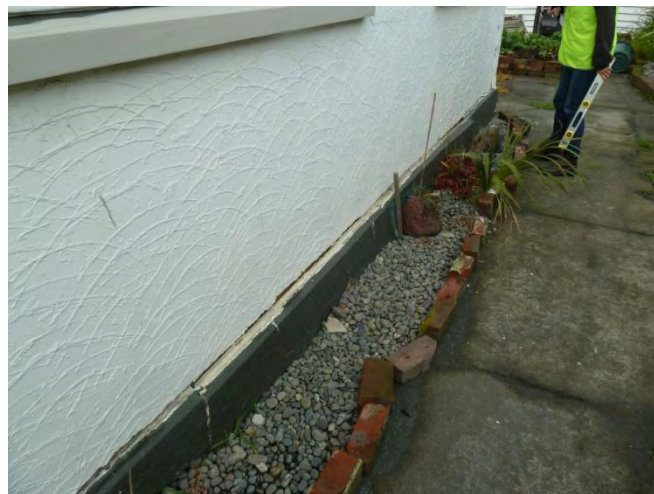
v) Foundation damage

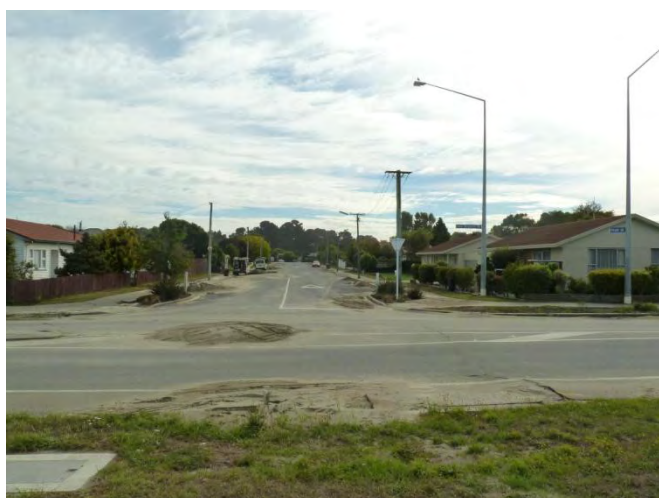
w) Liquefaction ejecta at a New Brighton Road junction

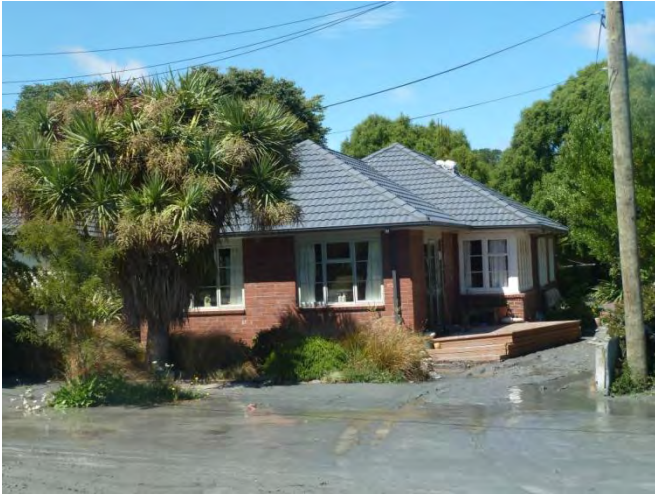
s) Foundation damage, tilting dwelling

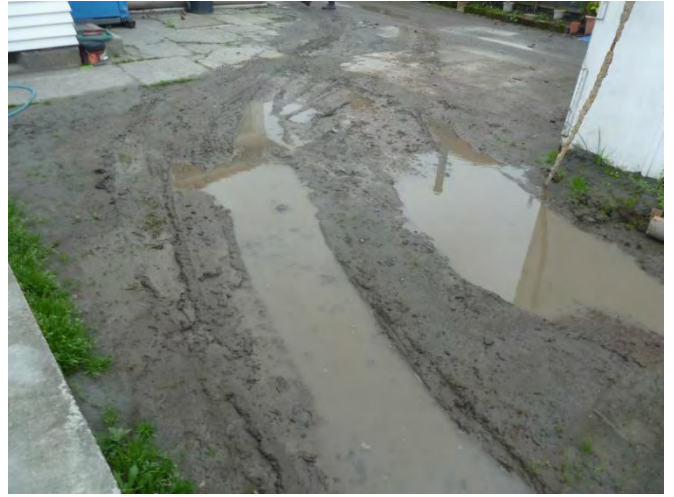
t) Liquefaction ejecta on driveway with water ponding

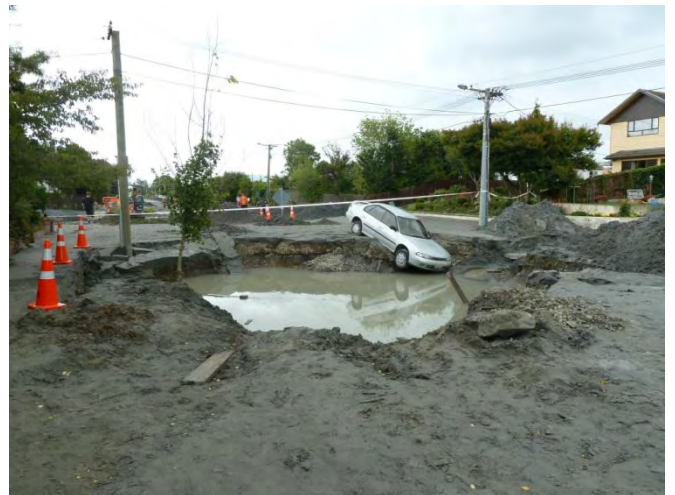
r) Close up photo of road damage seen in aerial photo of Woolston

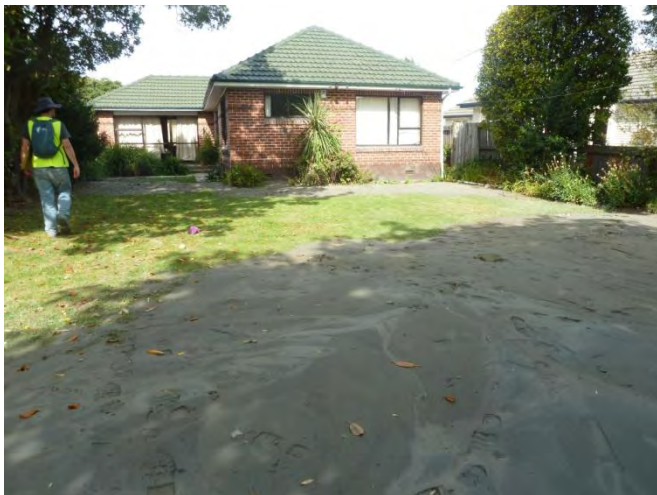
o) Liquefaction ejecta, dwelling tilting

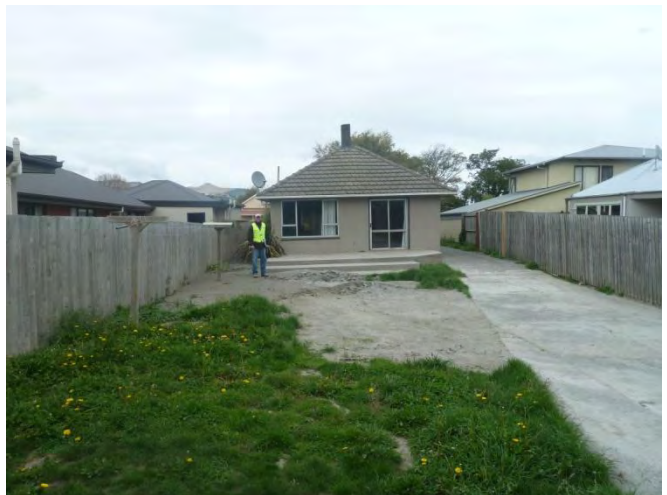
p) Liquefaction ejecta, dwelling tilting

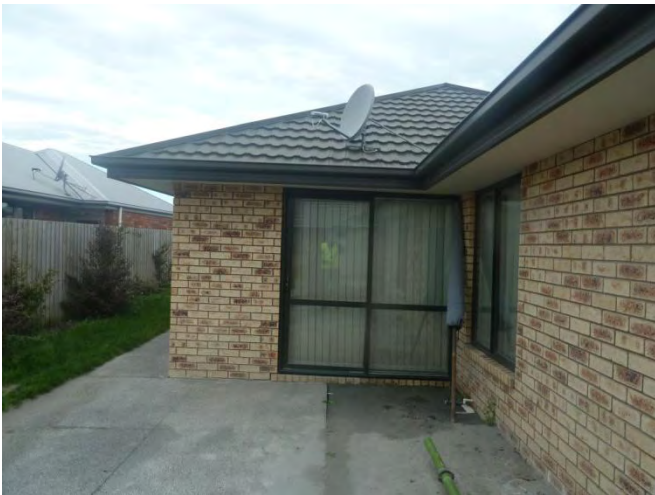
o) Foundation damage, dwelling tilting
