Ground Improvement Trials

Site 3 ( Wainoni )

Trial Area Layout

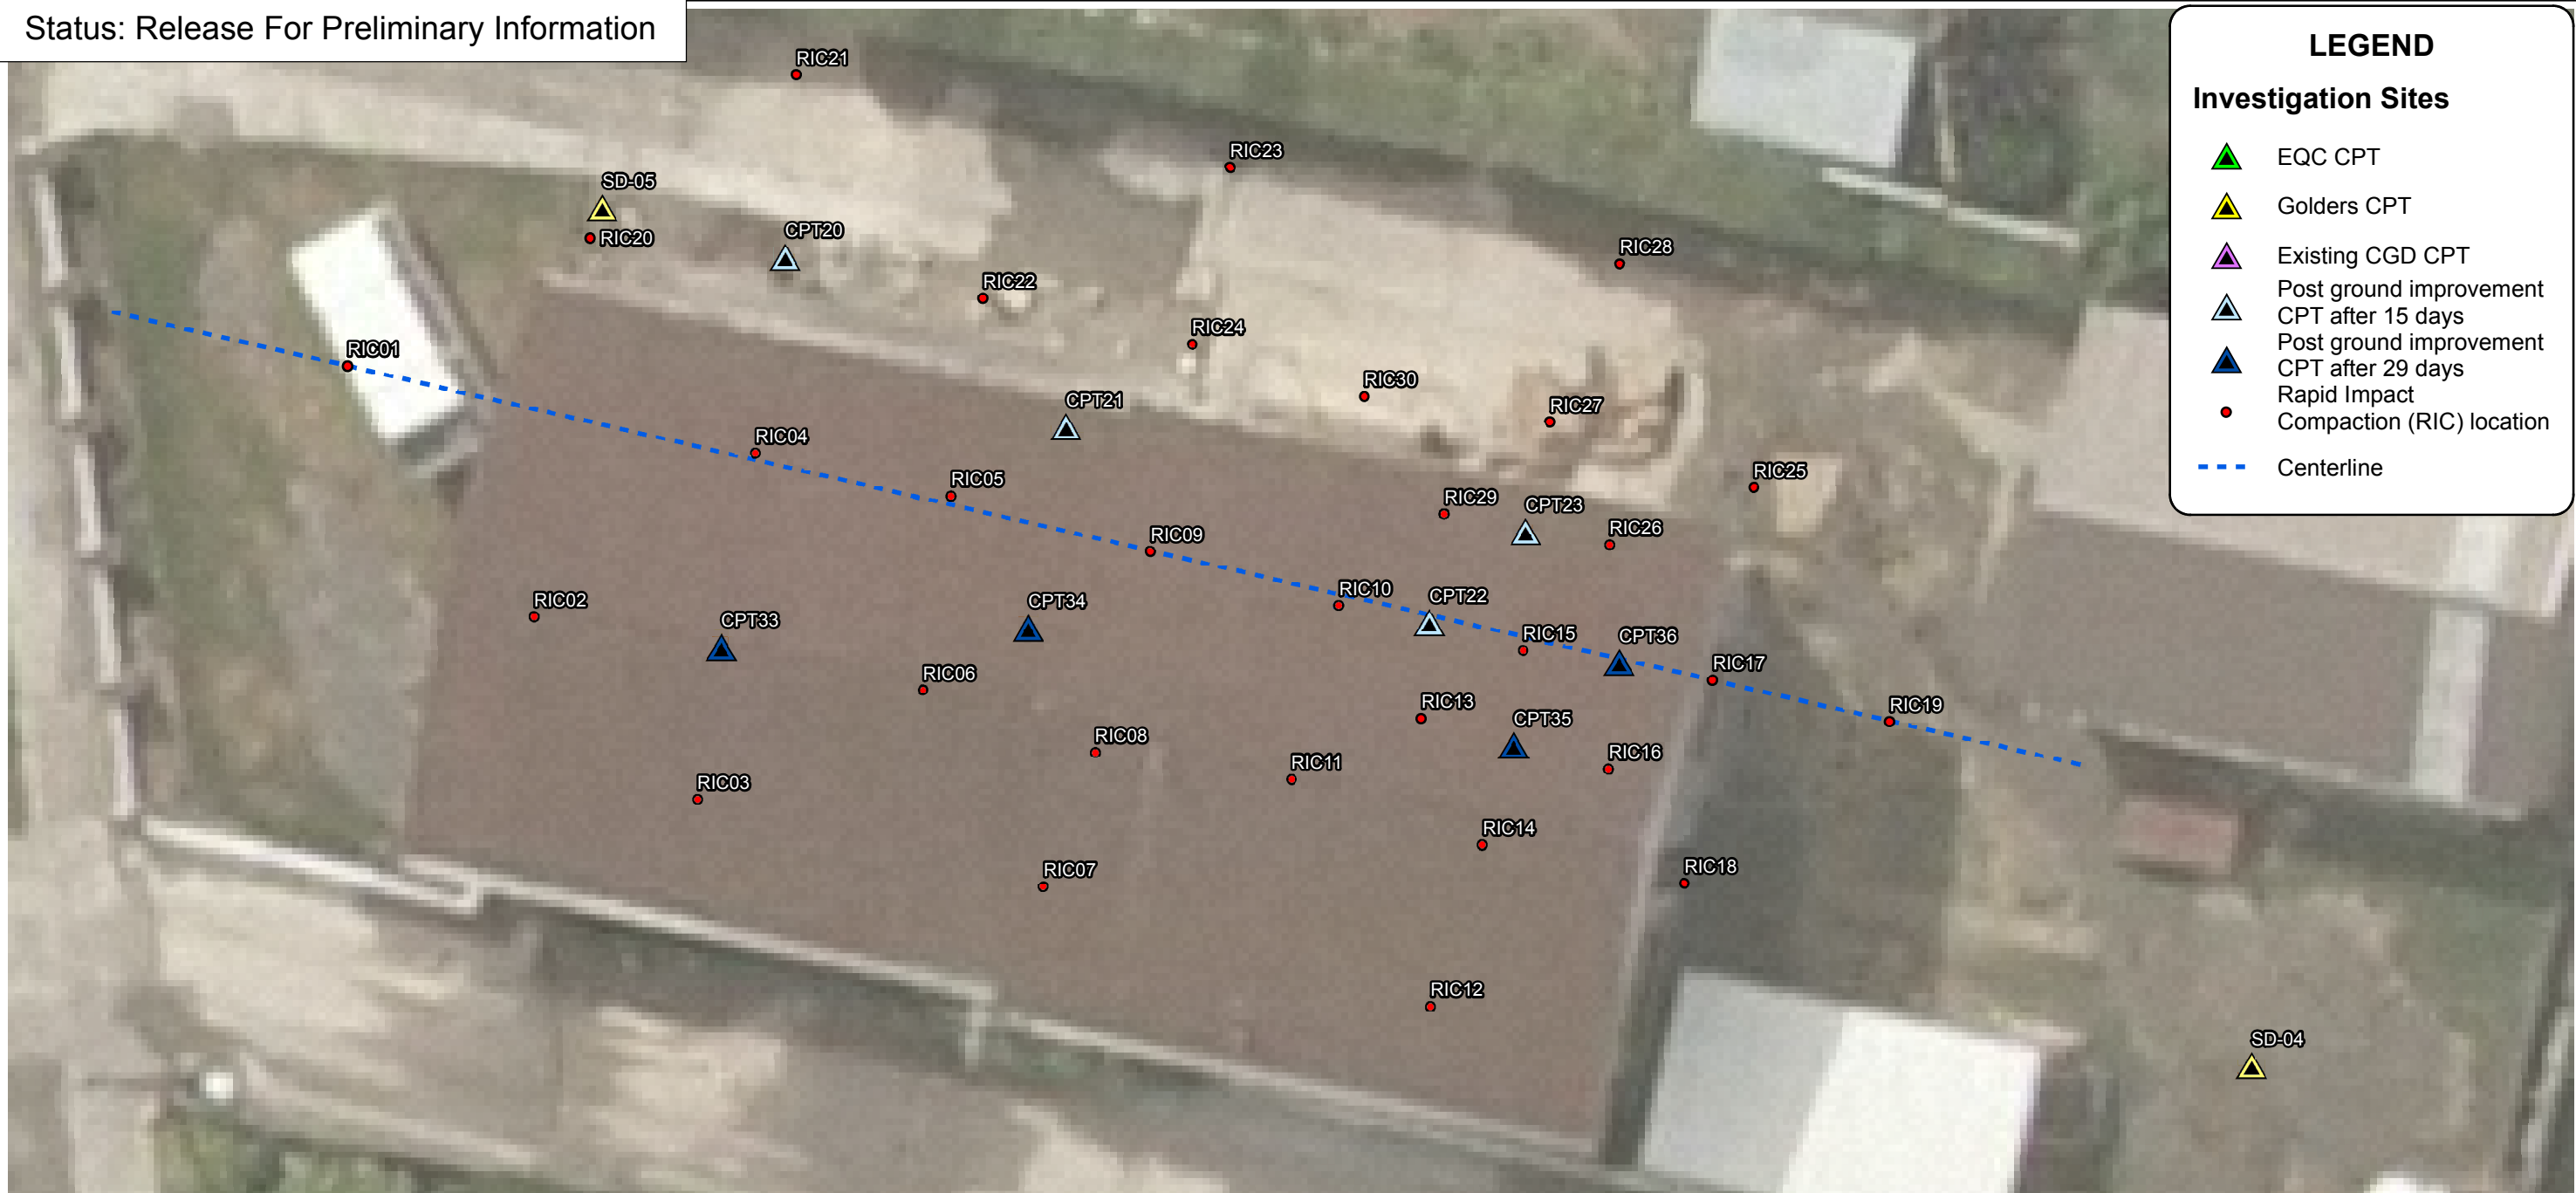
Rapid Impact Compaction Spacing Area

Rapid Impact  
Compaction (RIC) location

| ID | Coordinate (mN) | Coordinate (mE) | Date constructed | Order in which constructed | Applied Hammer drop height | # blows | Penetration depth (mm) | ID | Coordinate (mN) | Coordinate (mE) | Date constructed | Order in which constructed | Applied Hammer drop height | # blows | Penetration depth (mm) |

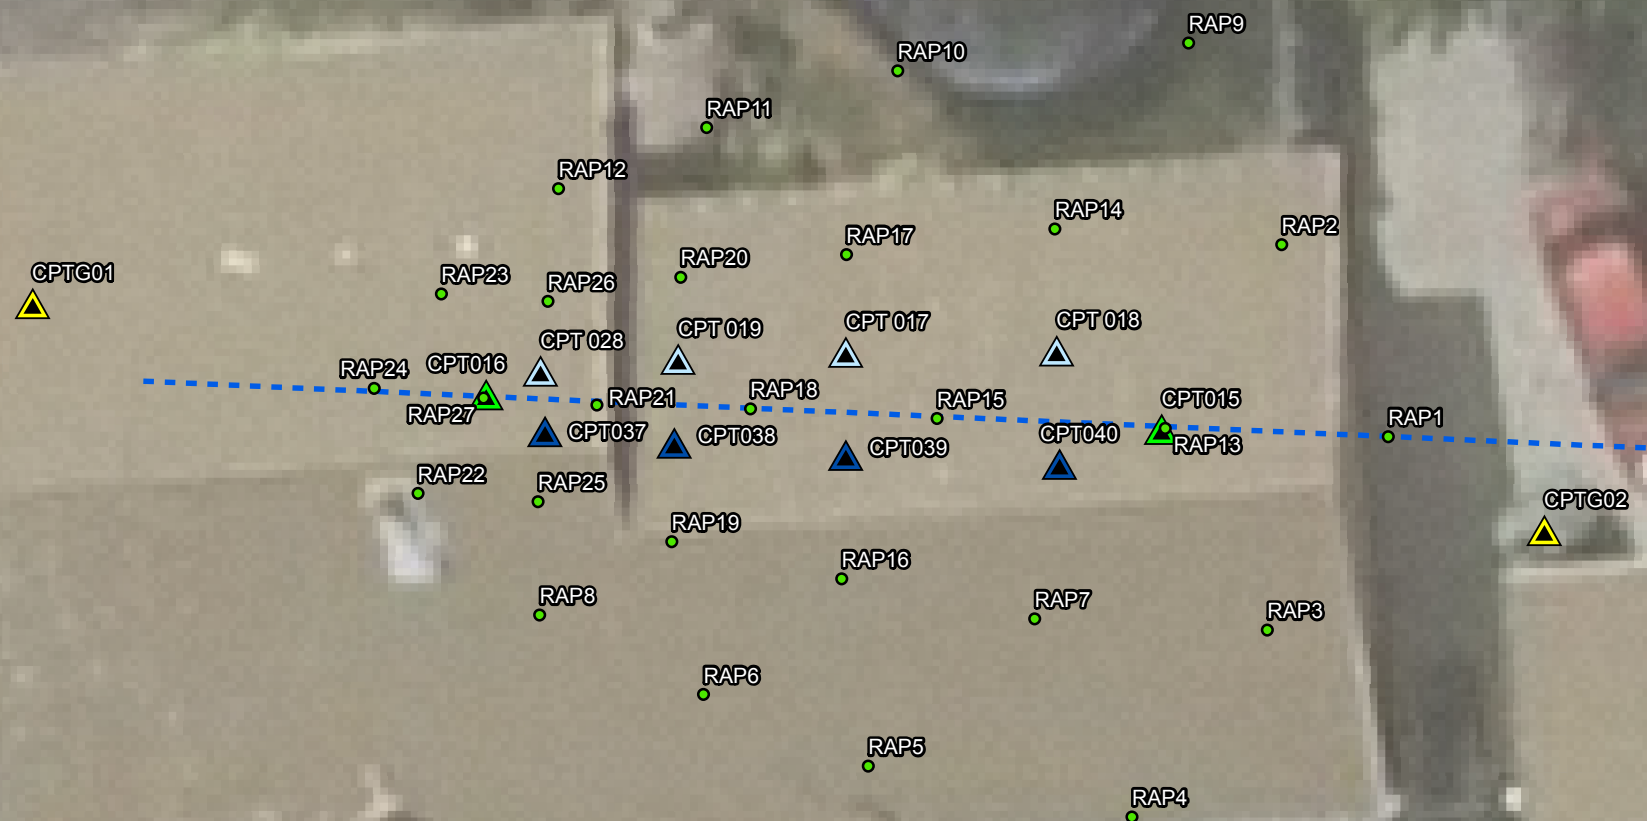
Ground Improvement Trials  
Site 3 (Wainoni)  
Rammed Aggregate Piers Spacing Area

Rammed Aggregate Piers (RAP) location
-

| ID | Coordinate (mN) | Coordinate (mE) | Date constructed | Order in which constructed | Depth of Pier (m) | Volume of aggregate used | ID | Coordinate (mN) | Coordinate (mE) | Date constructed | Order in which constructed | Depth of Pier (m) | Volume of aggregate used |

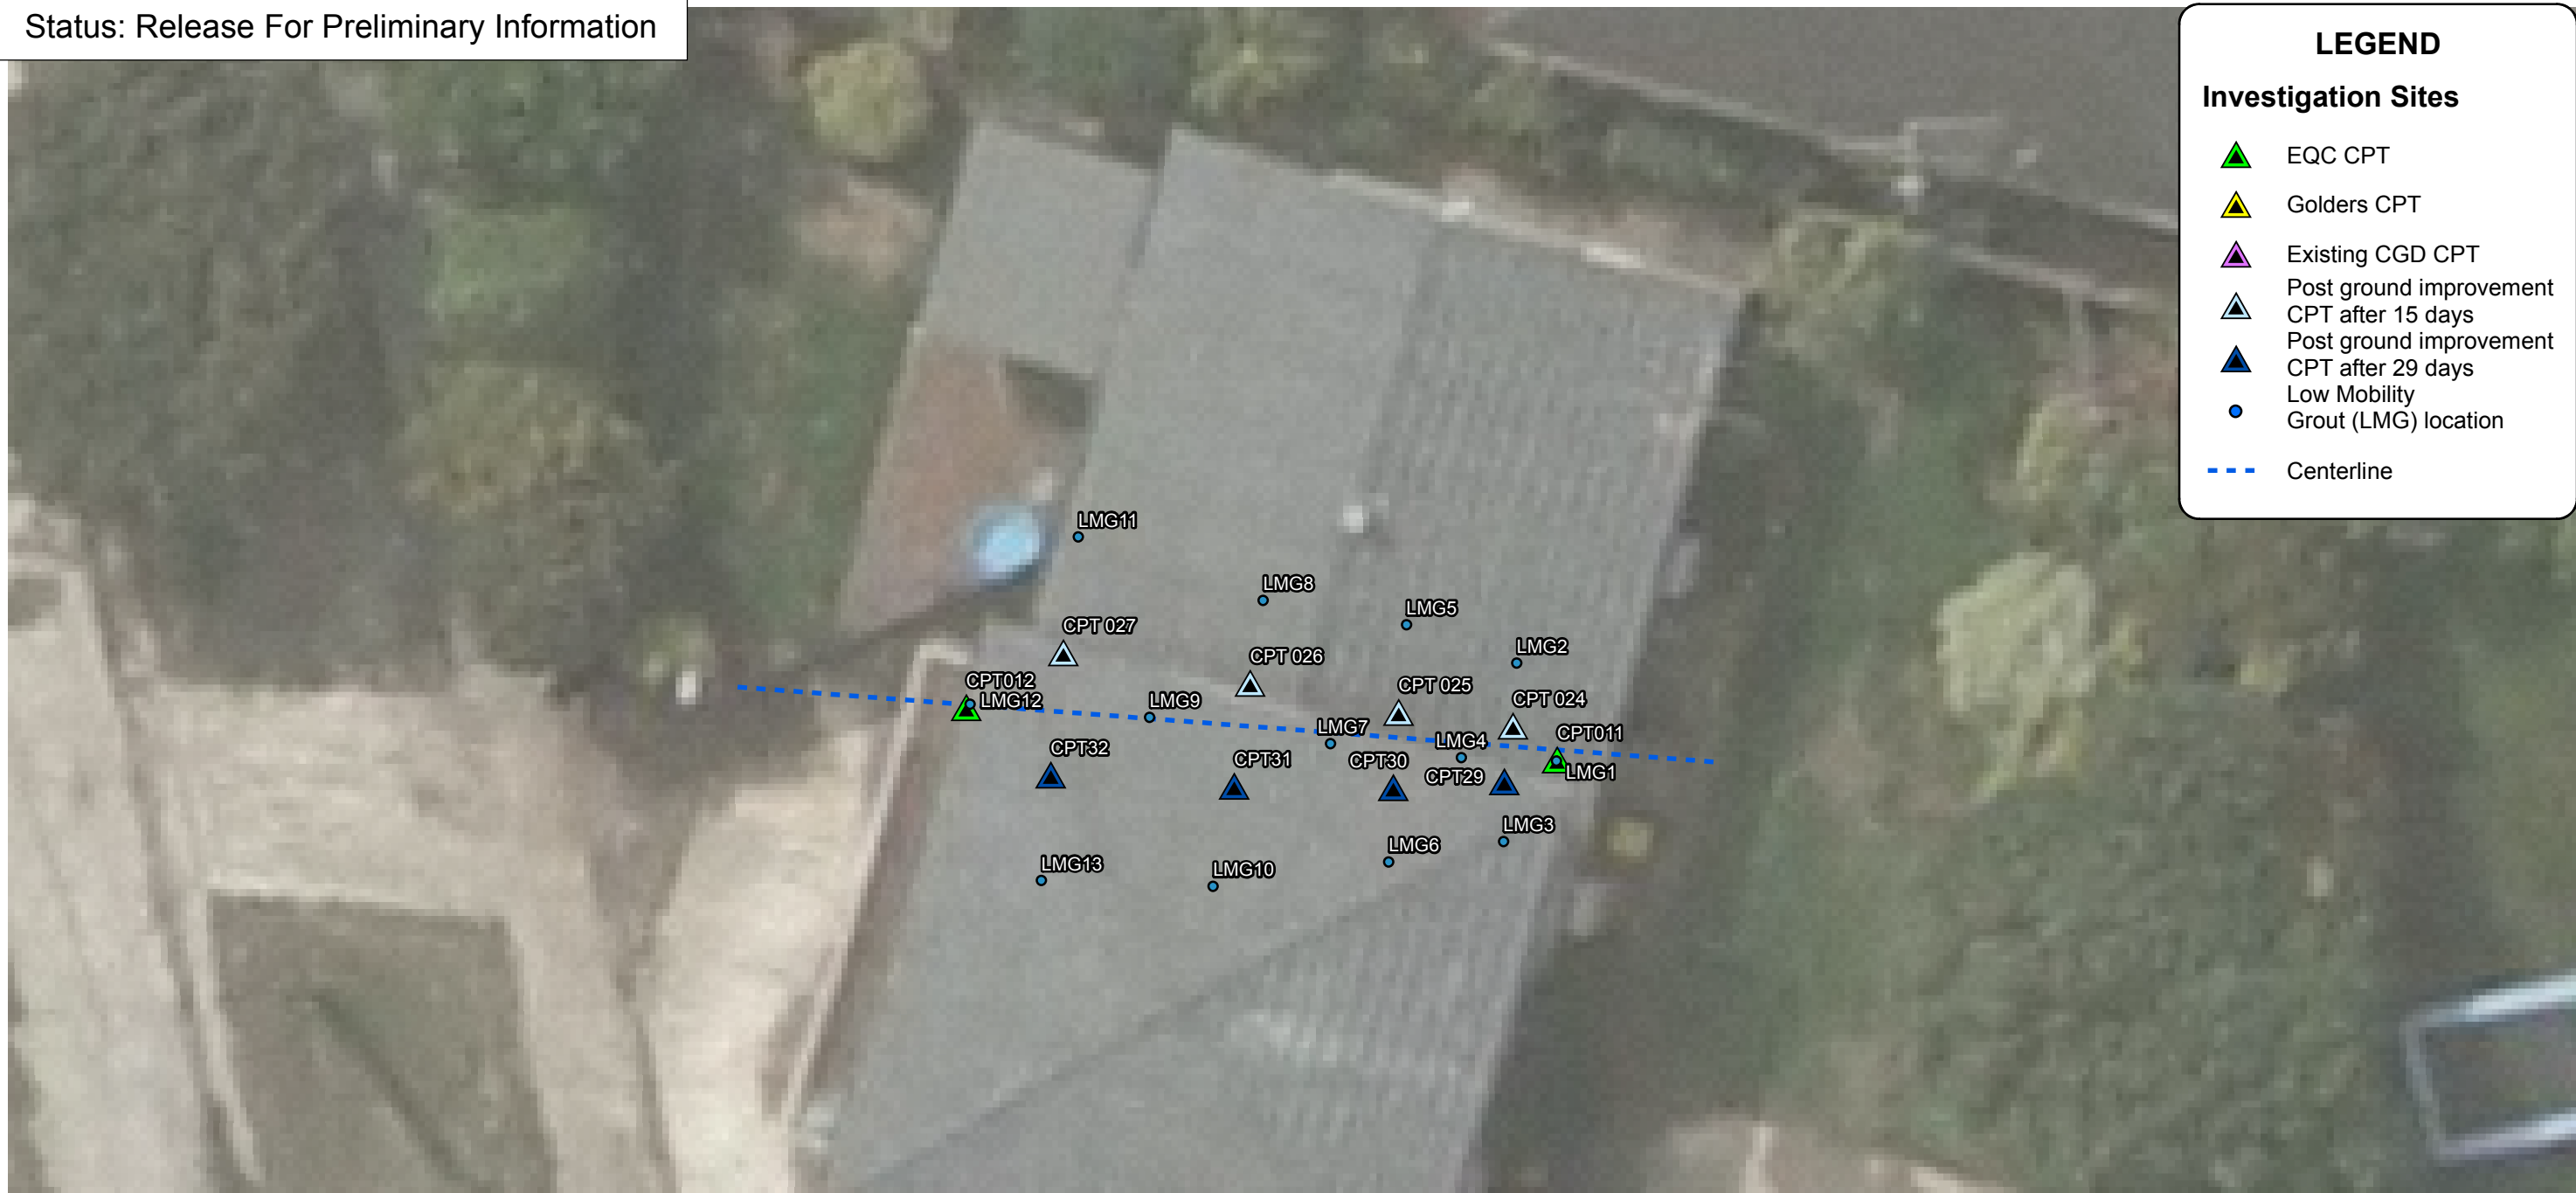
Low Mobility  
Grout (LMG) location

| ID | Coordinate (mN) | Coordinate (mE) | Order top bulbs constructed | Date top bulb constructed | Depth to centre of top bulb | Volume of grout in top bulb (m3) | Observed ground heave for top bulb | Order bottom bulbs constructed in | Date lower bulbs constructed | Depth to cente of bottom bulb | Volume of grout for bottom bulb | Observed ground heave for lower bulb |

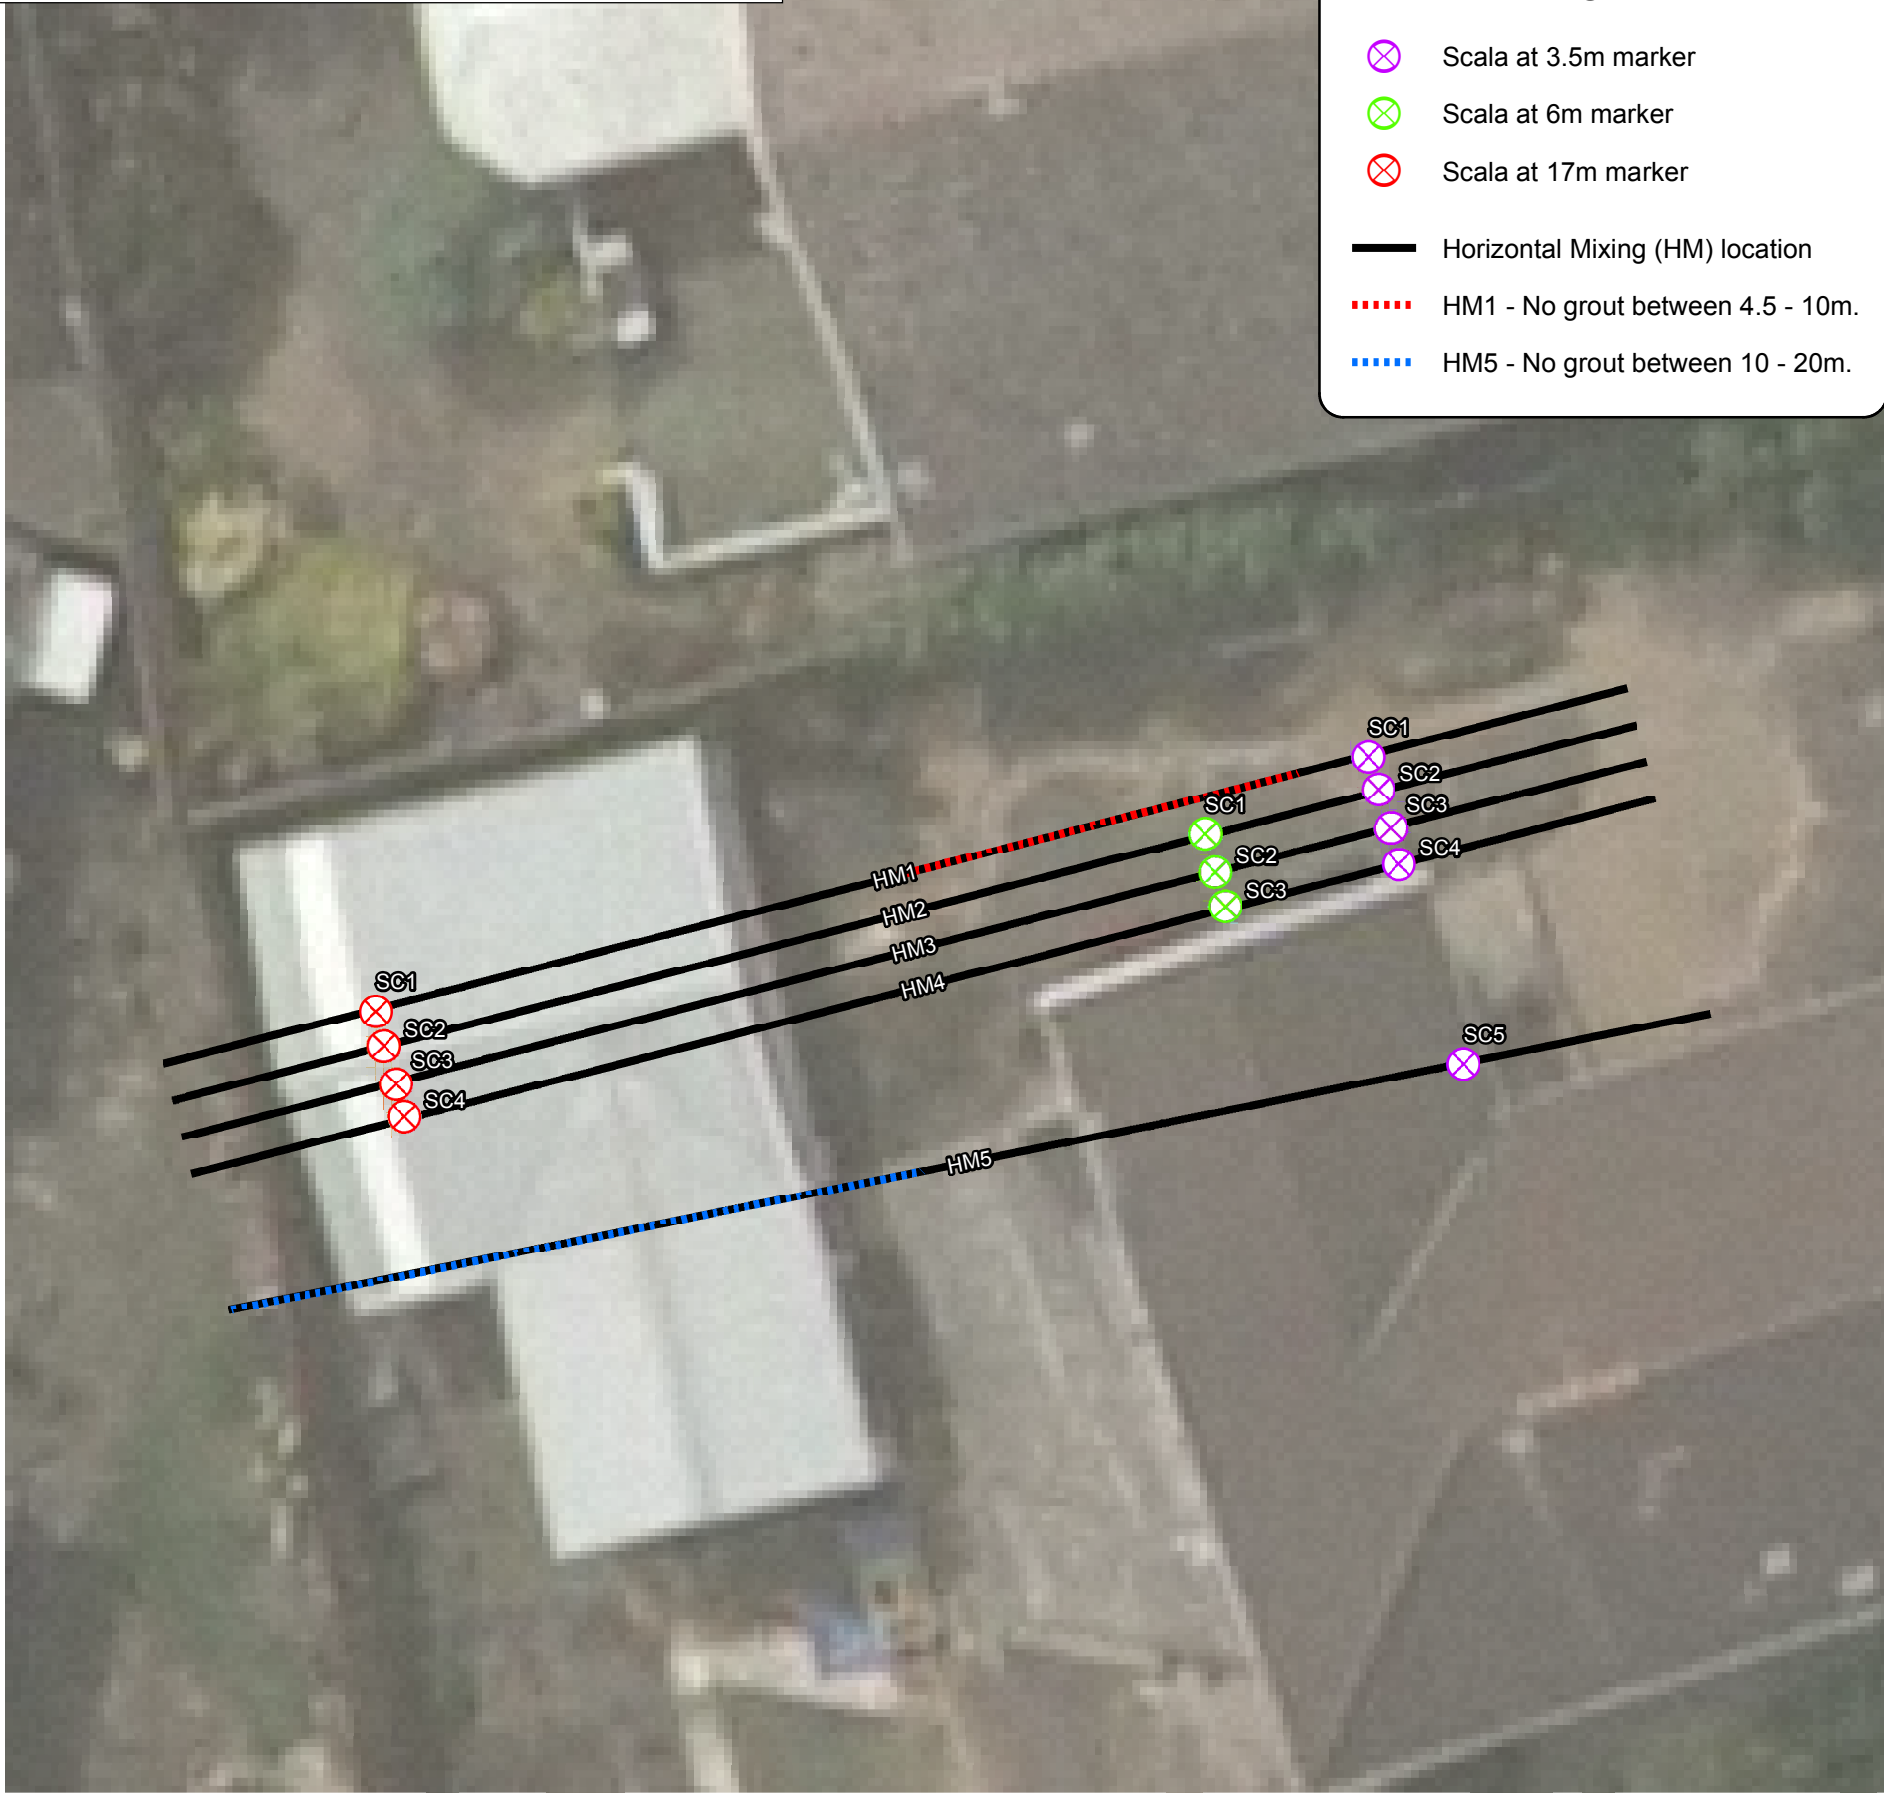
Horizontal Mixing Practice Area 1

Scala at 3.5m marker

Scala at 6m marker

| HM 1 (29-5-13) | | | | | | | |
|---|---|---|---|---|---|---|---|
| Distance (m) | Δ dist. (m) | Mix | Grout volume (L) | Cement % | Time to drill (m:s) | Pump pressure (PSI) | Comments |
