Ground Improvement Trials  
Site 4 ( Avondale )  
Trial Area Layout

Ground Improvement Trials

Site 4 (Avondale)

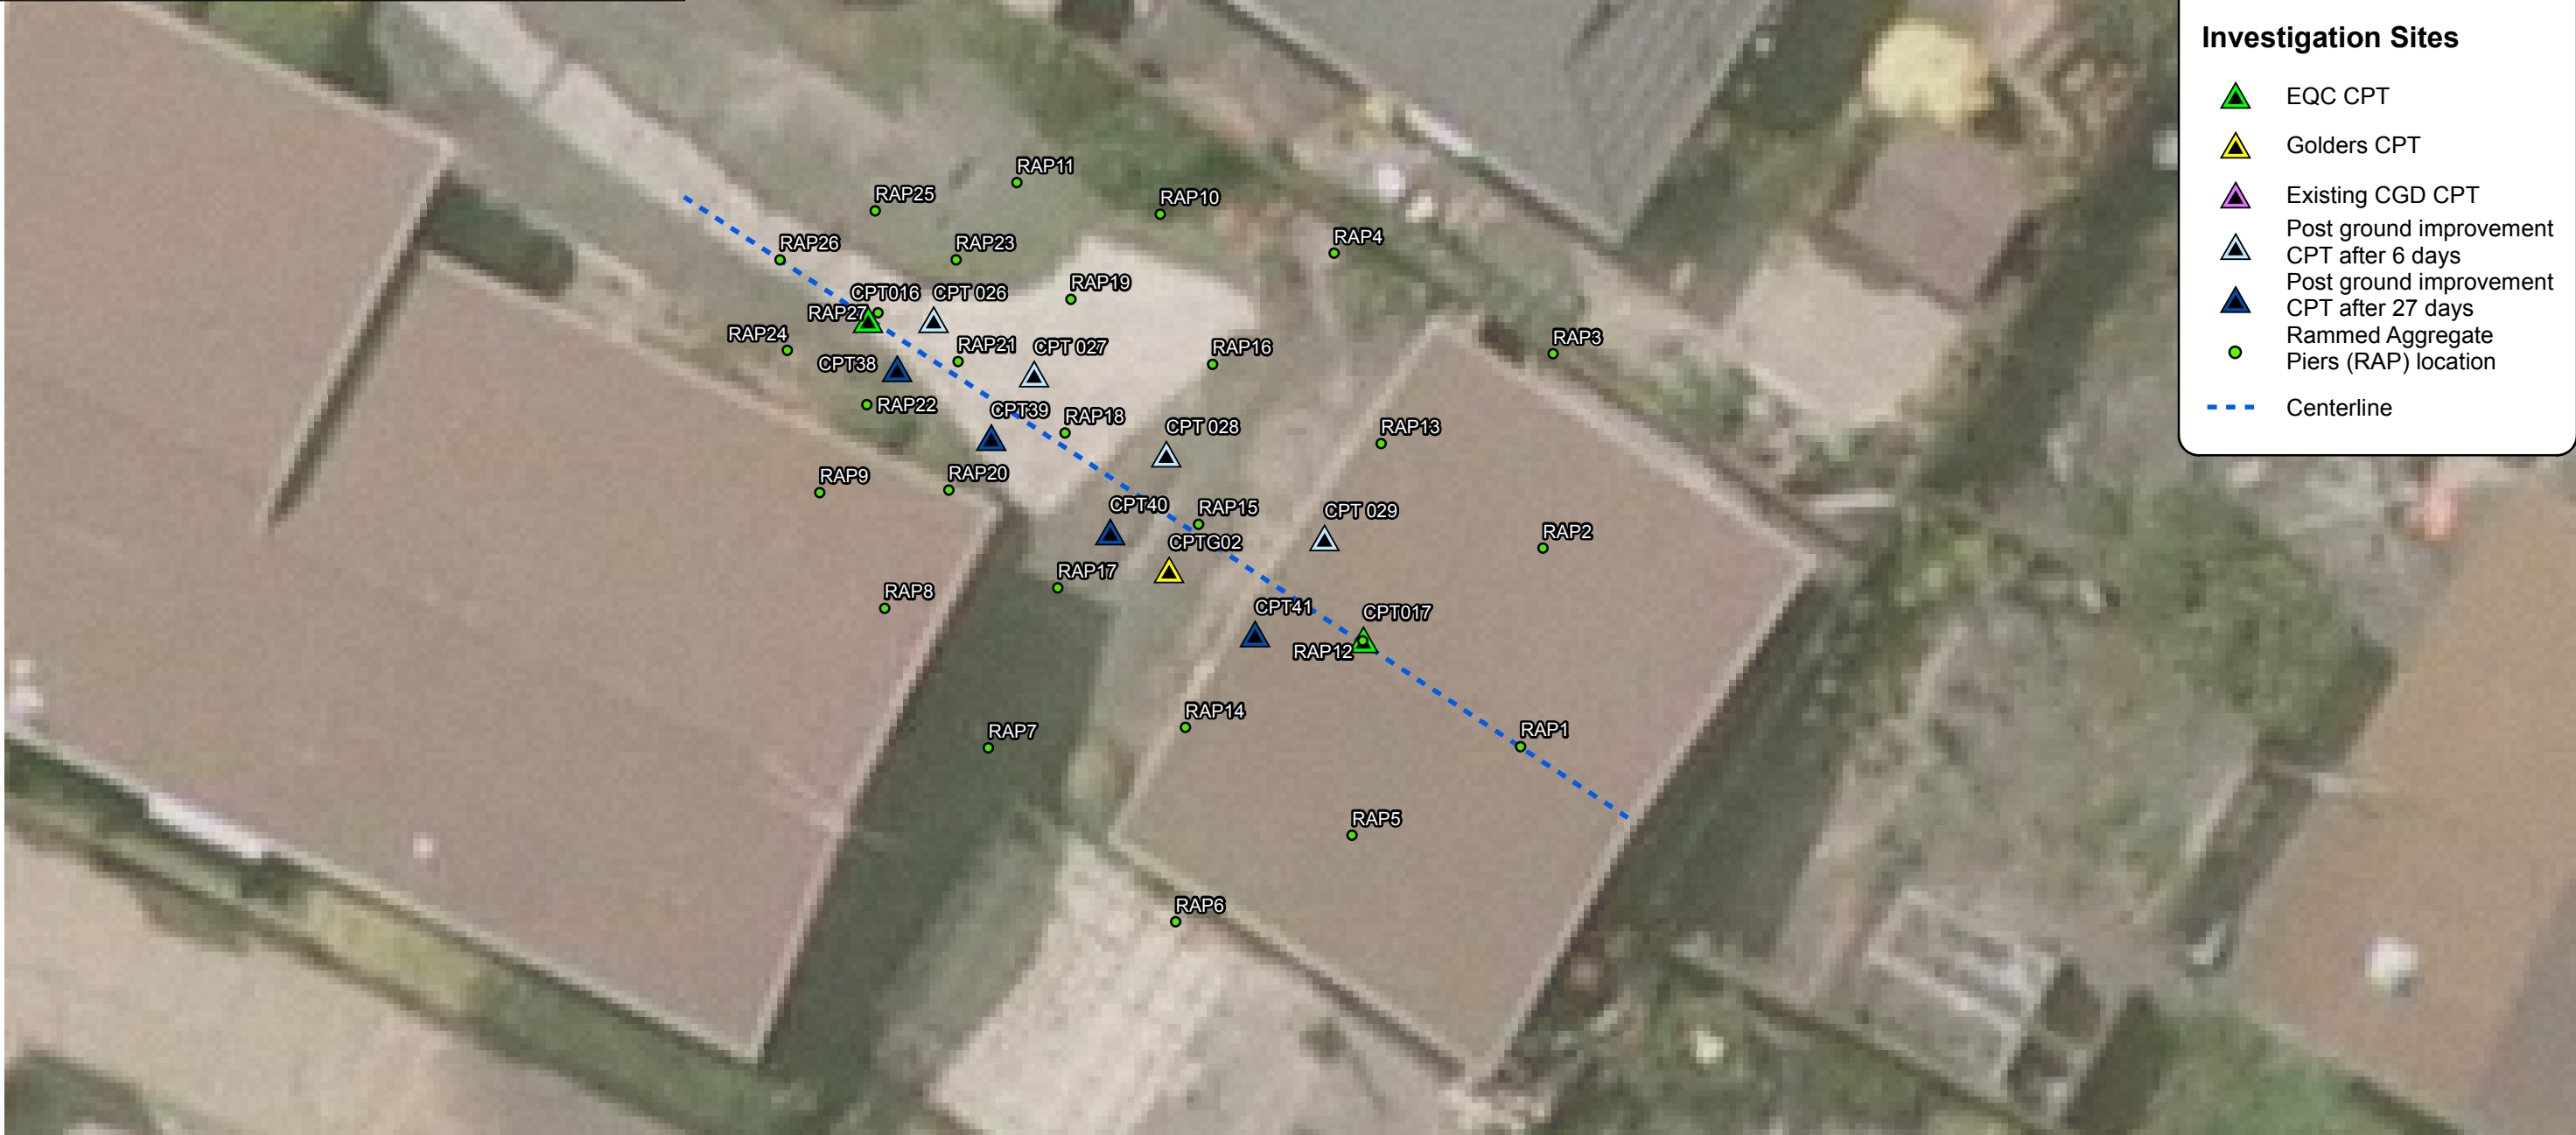
Rammed Aggregate Piers Spacing Area

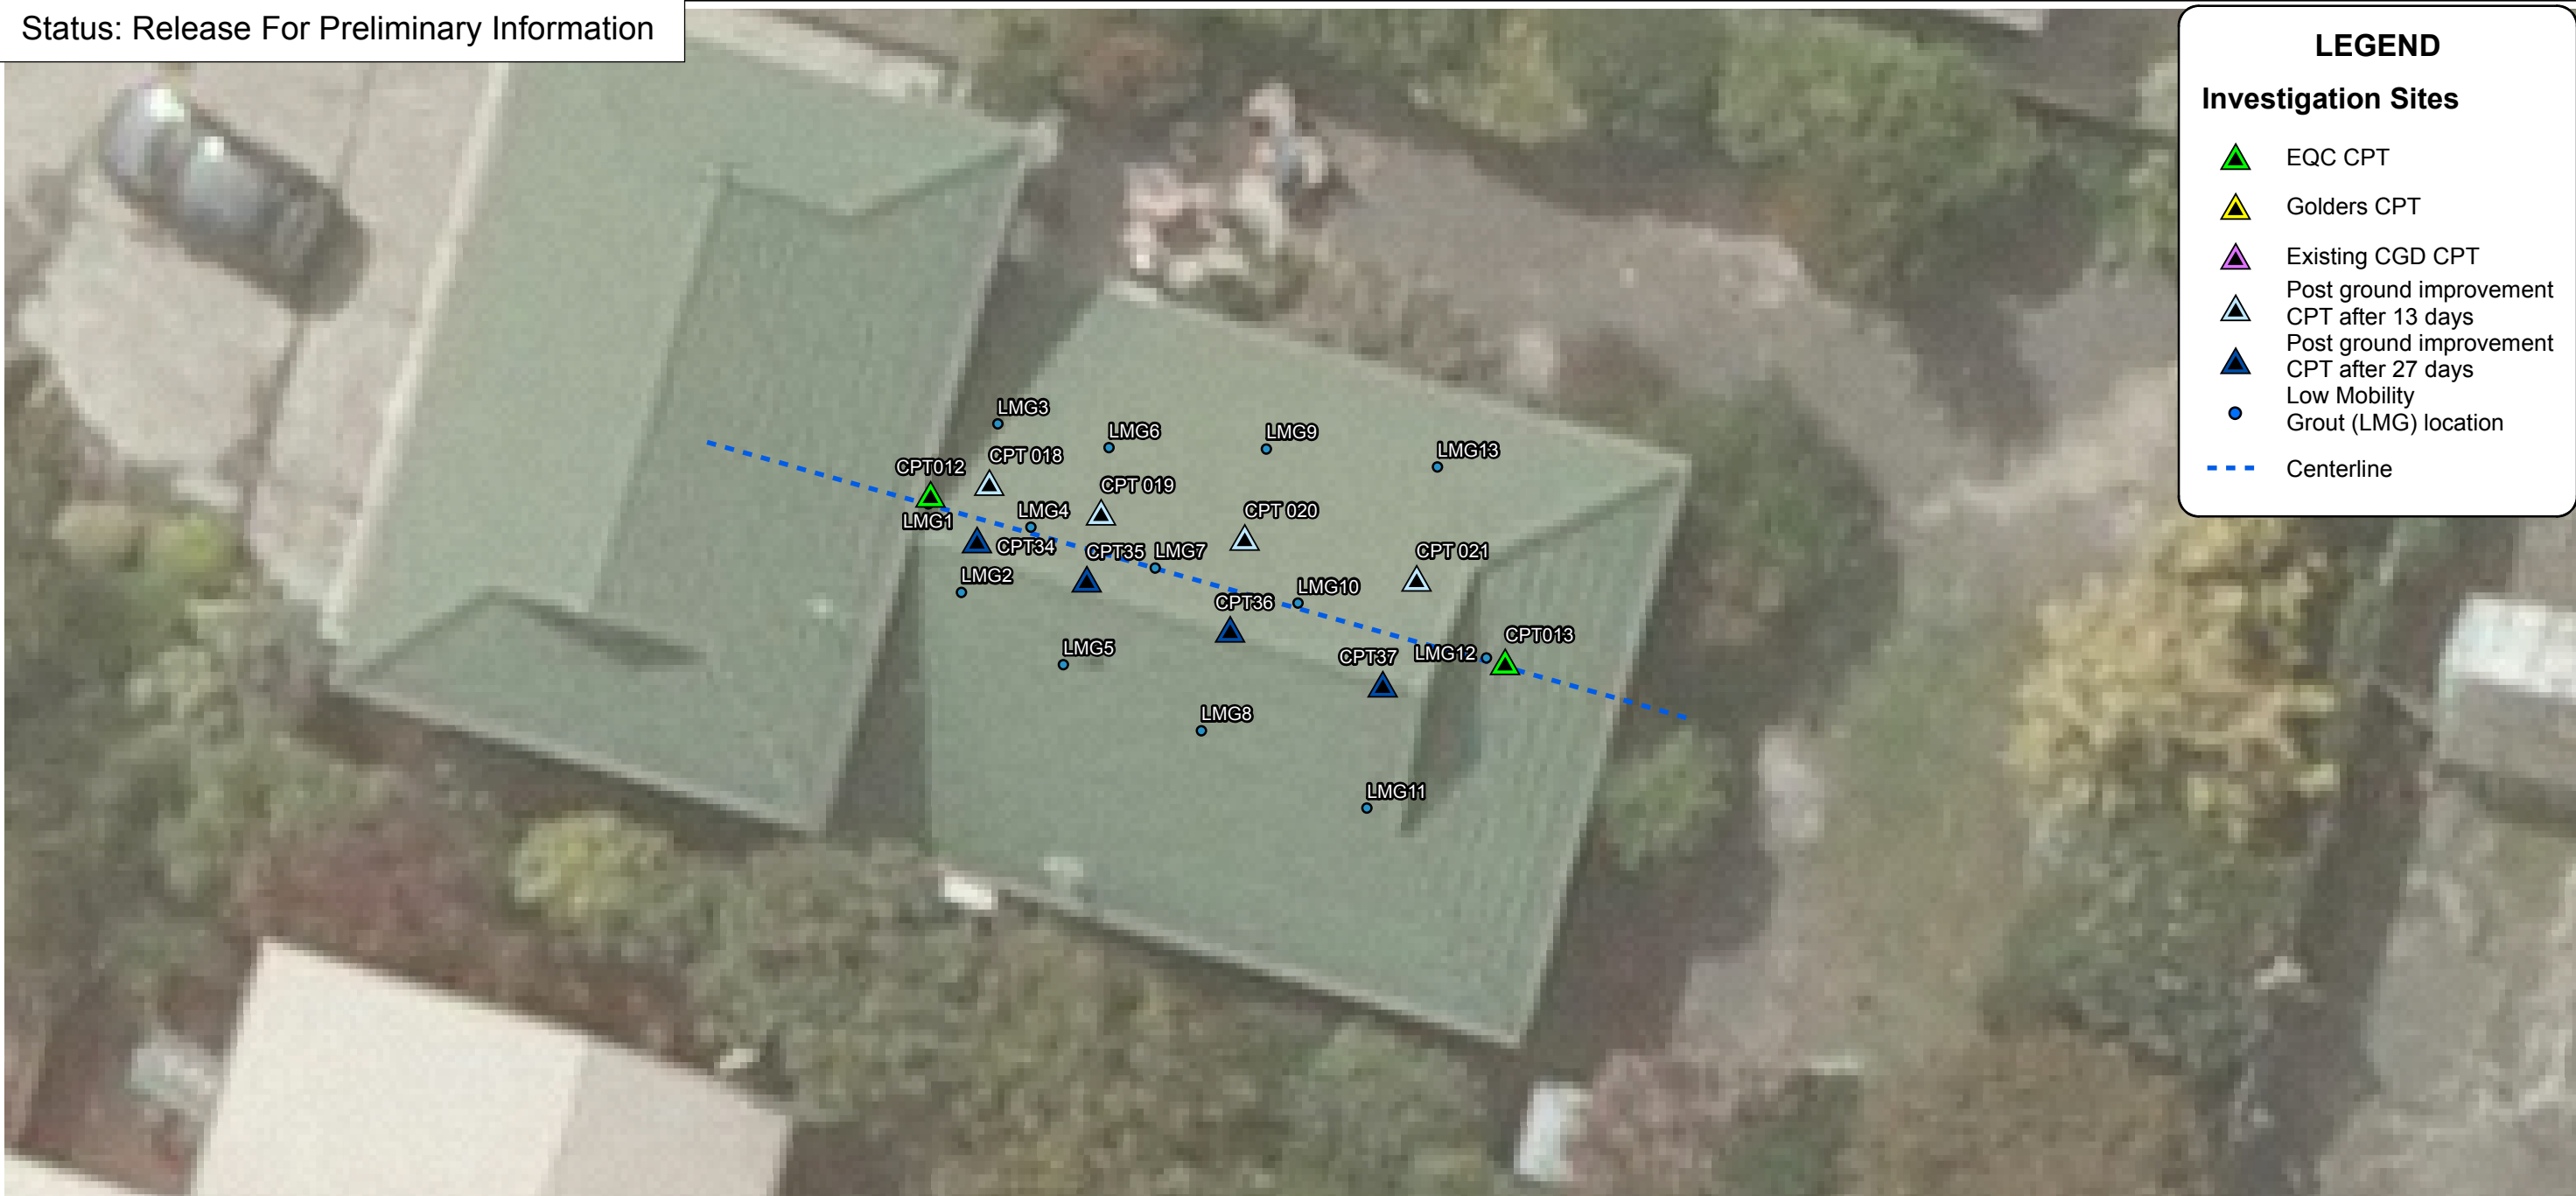
| Ref: 52020-0200 | 1D4 | |

Low Mobility Grout Spacing Area
