Ground Improvement Trials  
Site 6 ( Bexley )  
Trial Area Layout

Ground Improvement Trials  
Site 6 (Bexley)  
Rapid Impact Compaction Spacing Area

Ground Improvement Trials

Site 6 (Bexley)

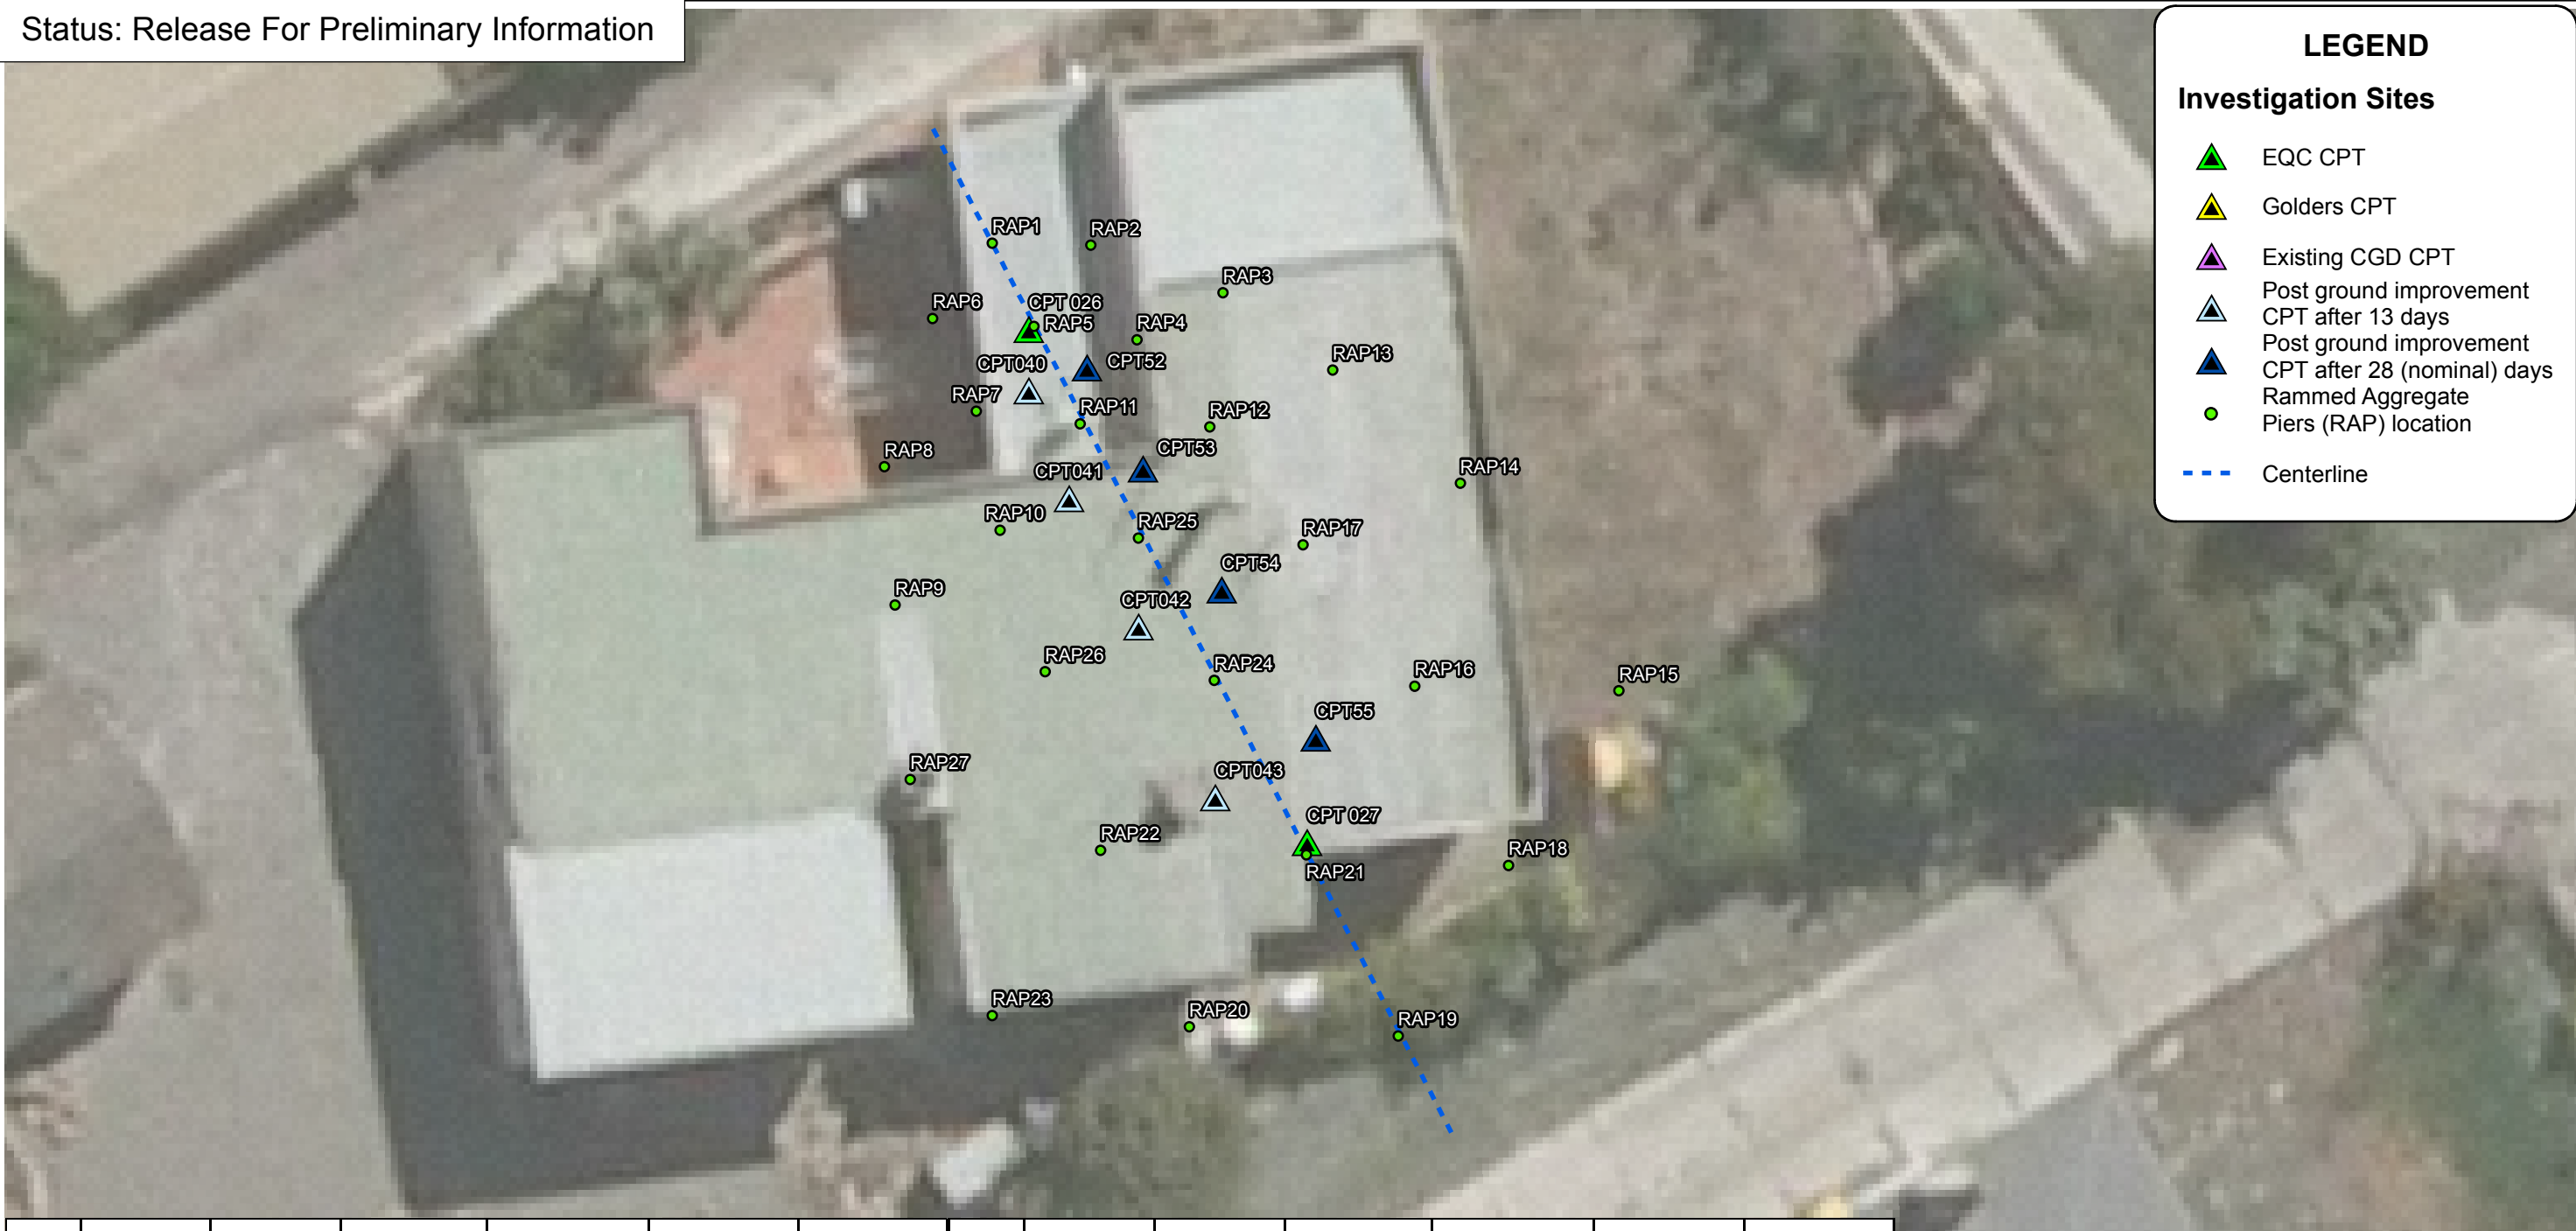
| Ref: 52020-0200 | 1C6 | |

Rammed Aggregate Piers Spacing Area

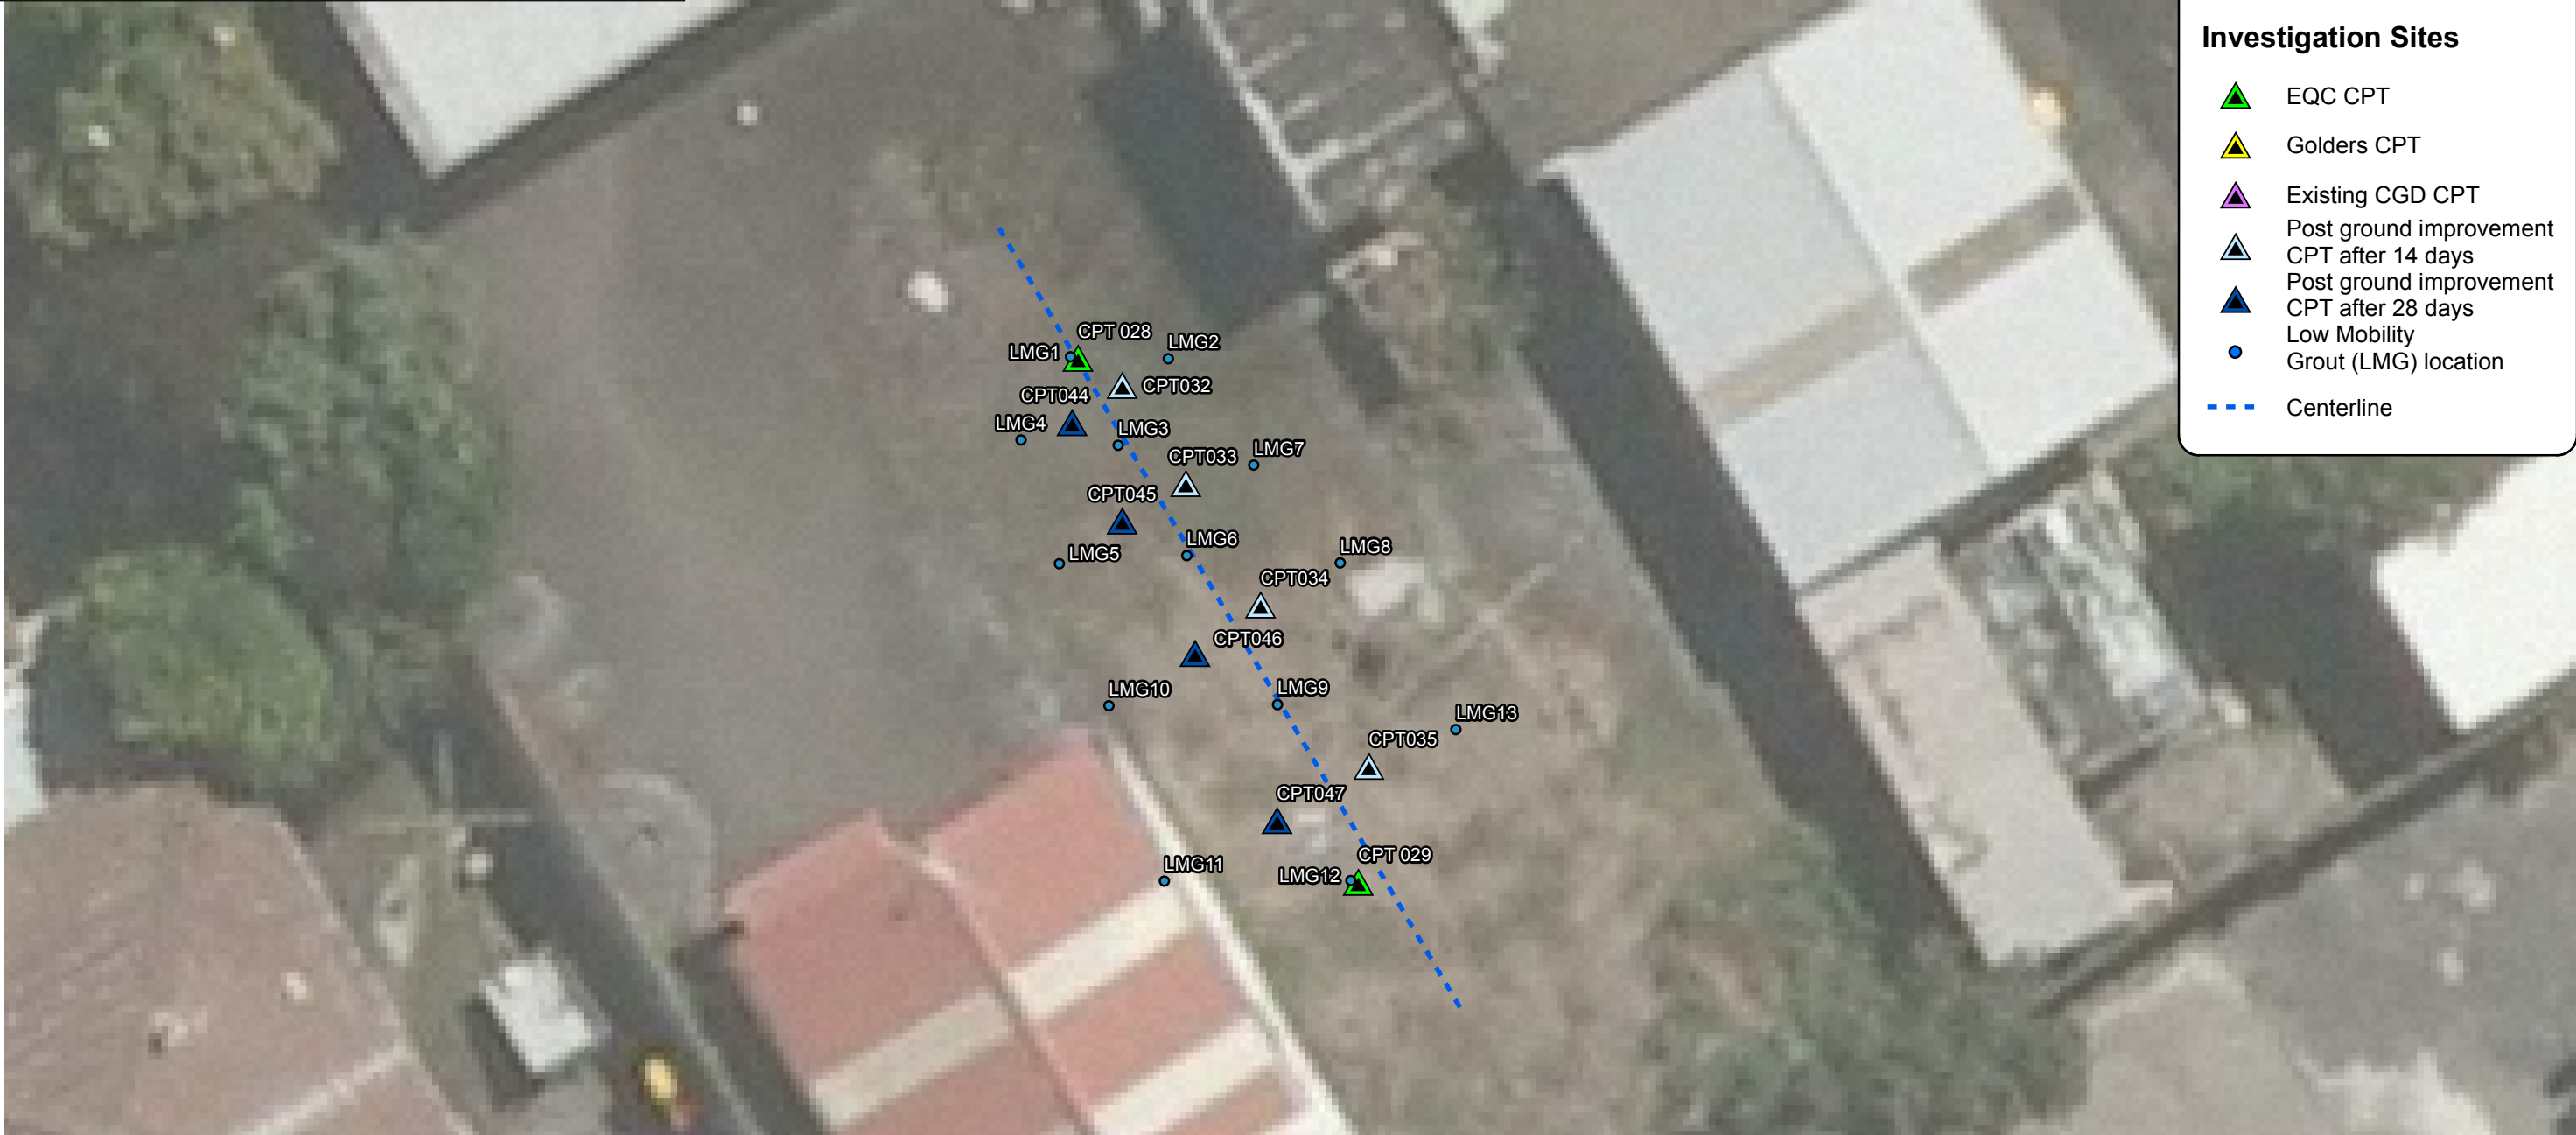
| Ref: 52020-0200 | 1D6 | |

Low Mobility Grout Spacing Area
