## Appendix N: LSN Examples

## **N1 Introduction**

## **Typical Photographs of LSN Ranges**

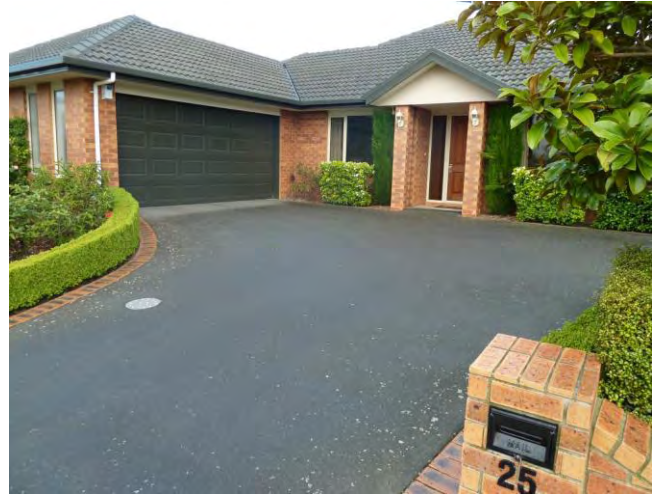
b) Undamaged asphalt driveway

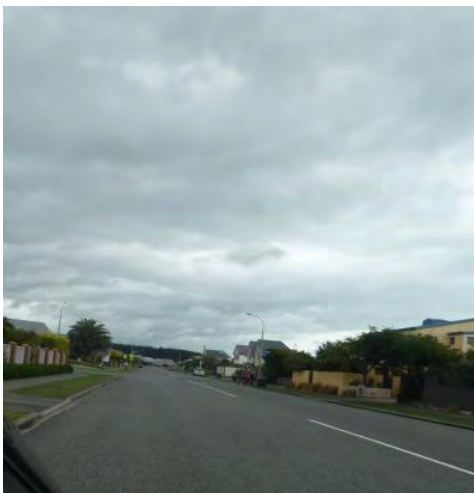
e) View of Aston Drive with little damage

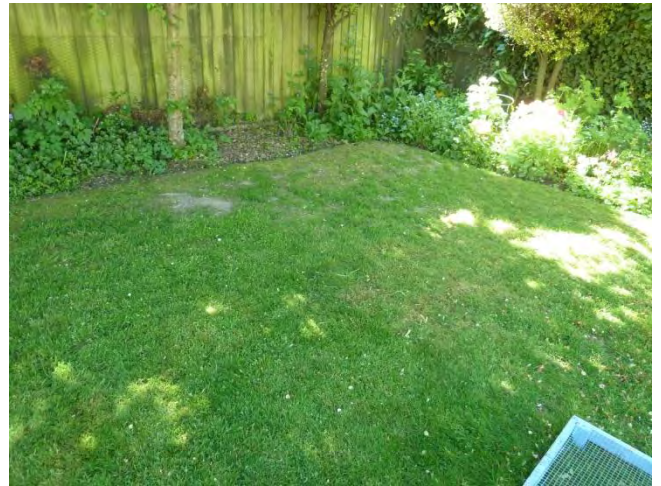
j) Liquefaction ejecta on lawn

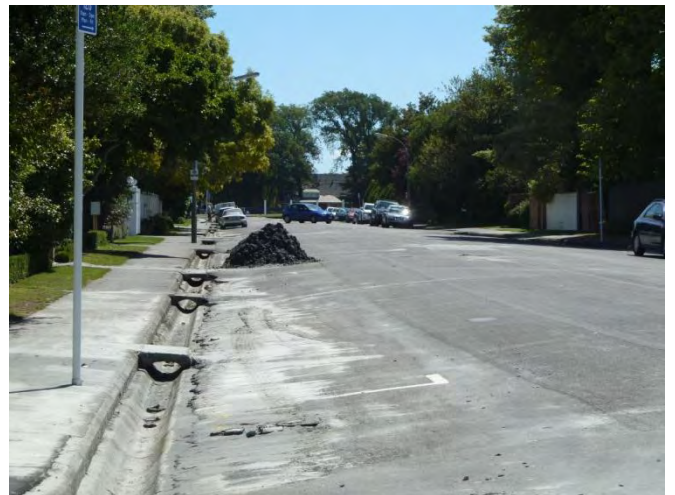
l) Liquefaction ejecta pile on road

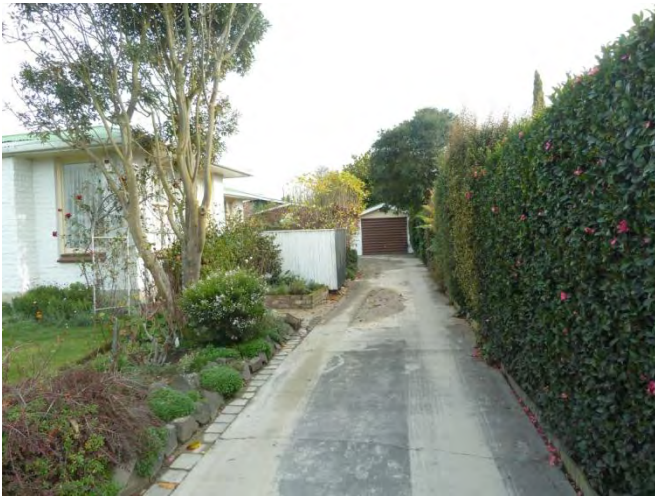
s) Liquefaction ejecta on driveway

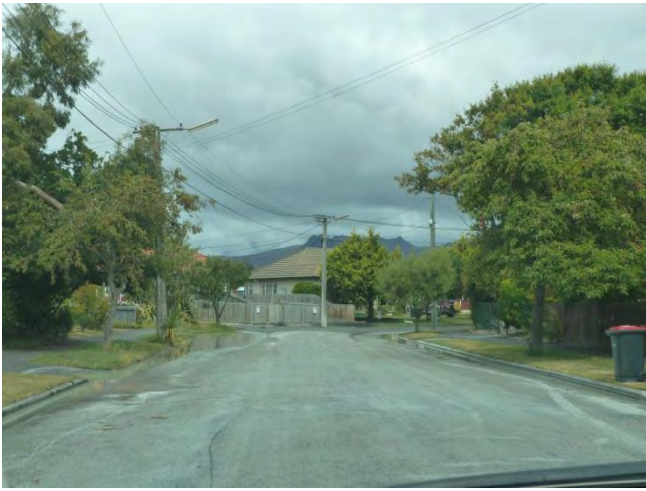
y) Undulations on road with ponding water

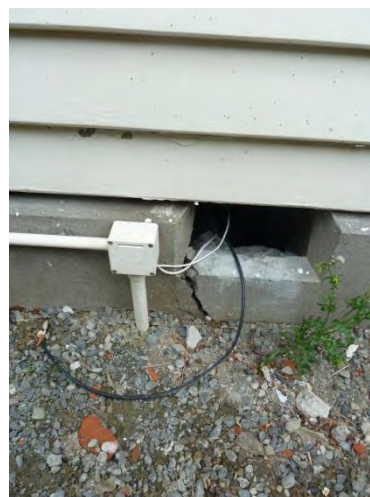
t) Foundation damage

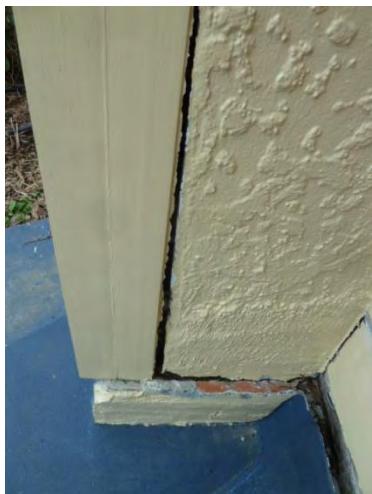
u) Foundation damage

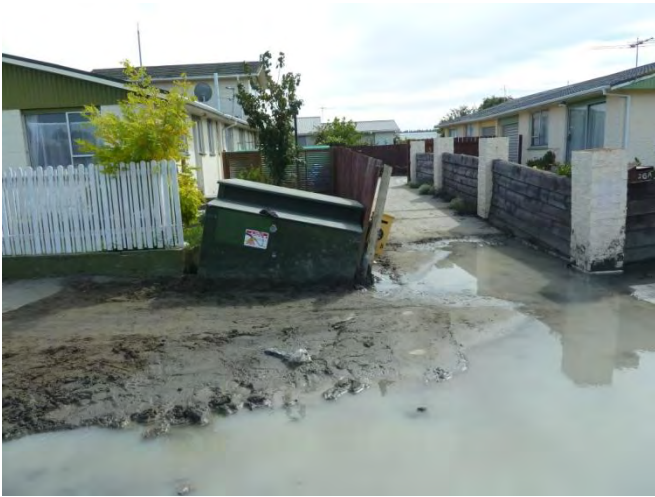
Figure N8.Y

y) Sinking electricity box with liquefaction ejecta and ponding water

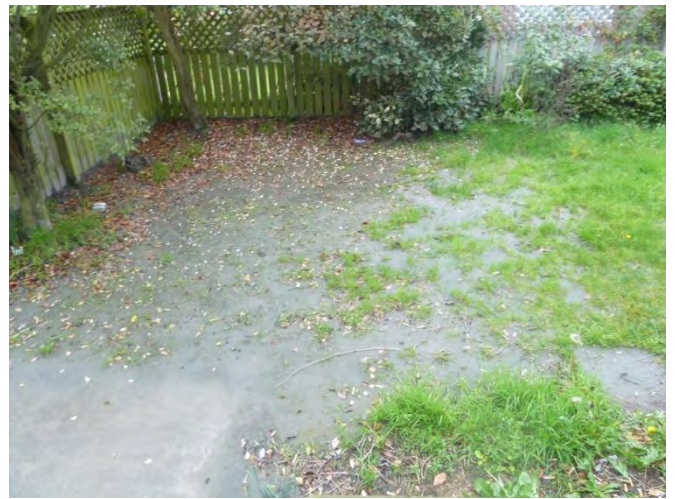
b) Liquefaction ejecta on lawn

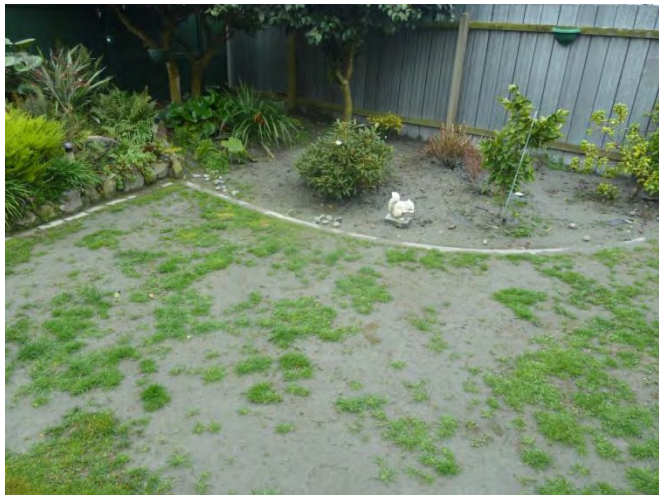
c) Liquefaction ejecta on lawn

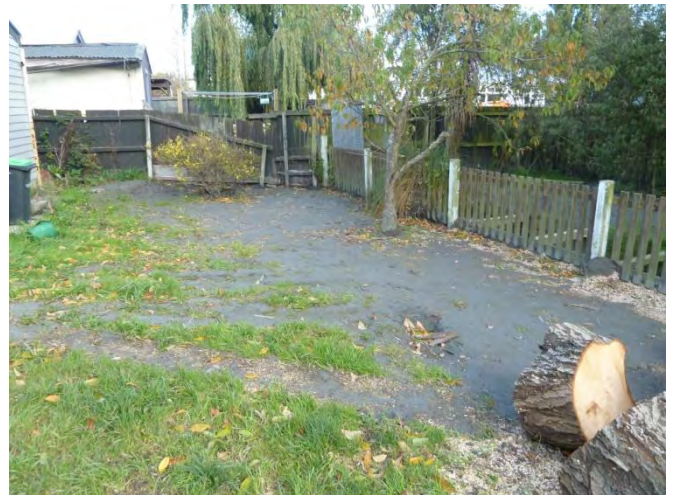
d) Liquefaction ejecta on lawn

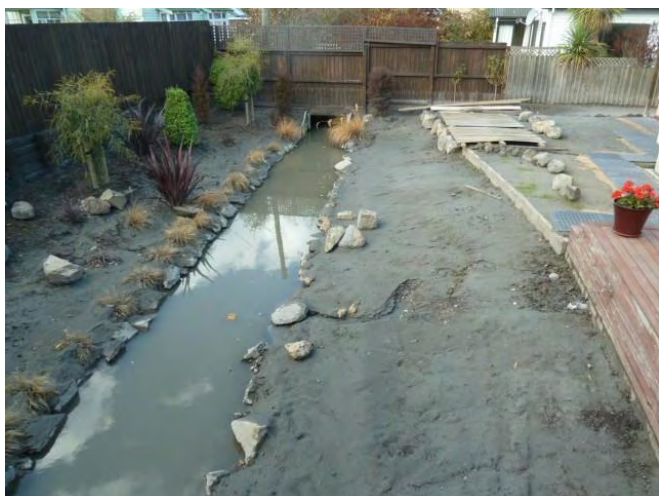
e) Liquefaction ejecta alongside culvert

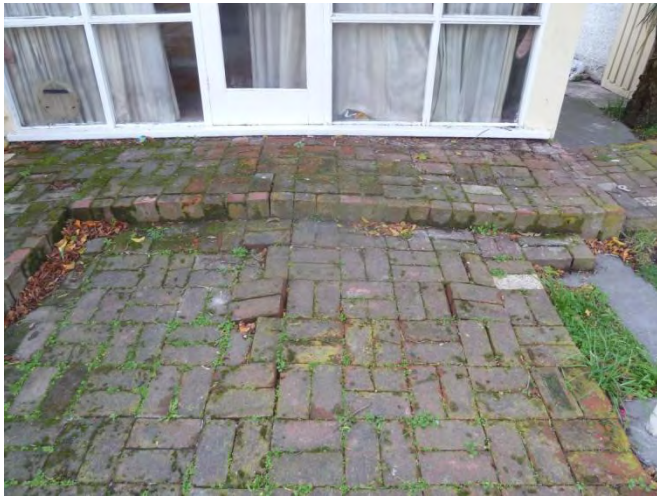
a) Undulating paving bricks

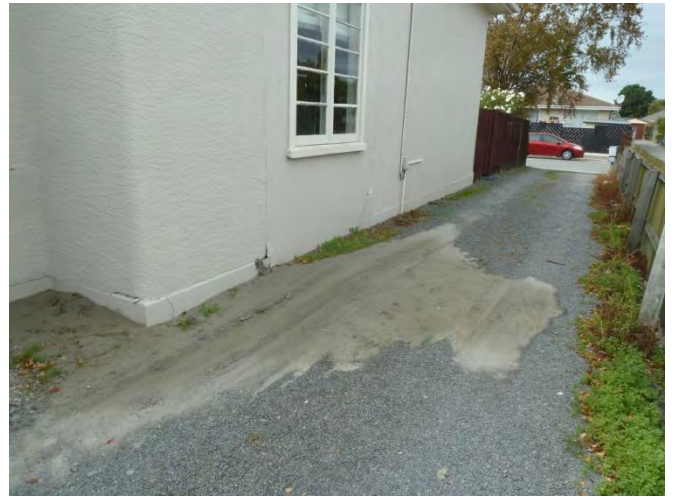
b) Isolated area of liquefaction ejecta

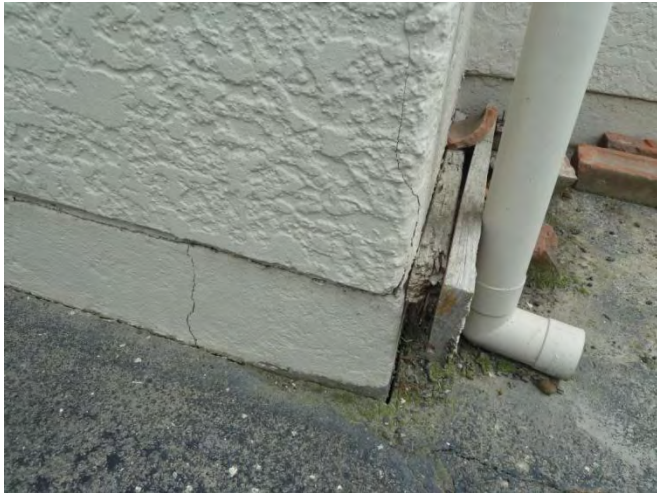
c) Foundation damage

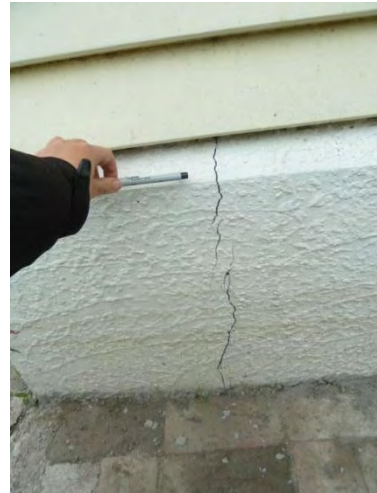
d) Foundation damage

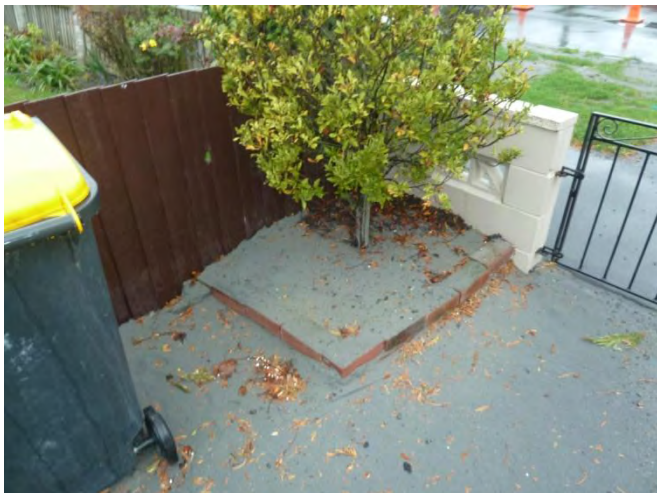
e) Liquefaction ejecta

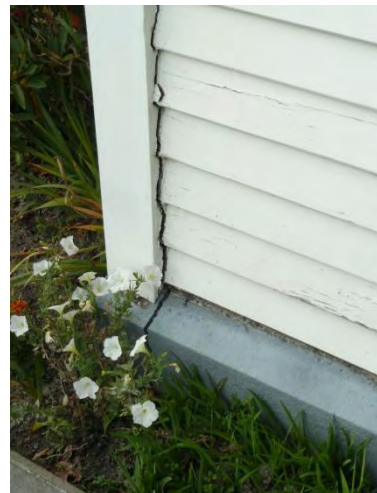
f) Foundation damage

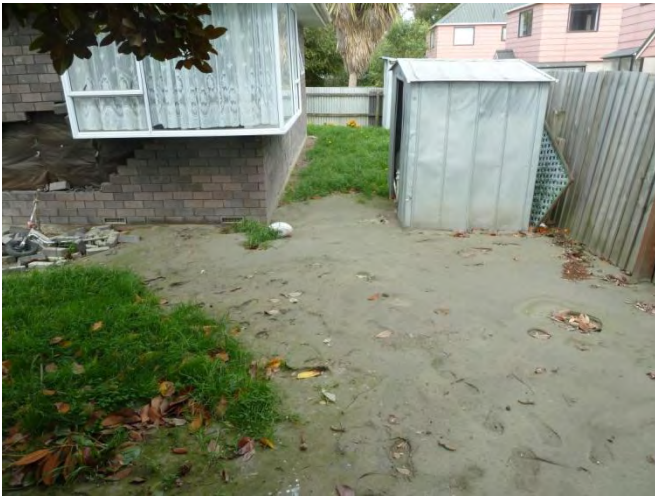
m) Liquefaction ejecta and brickwork damage

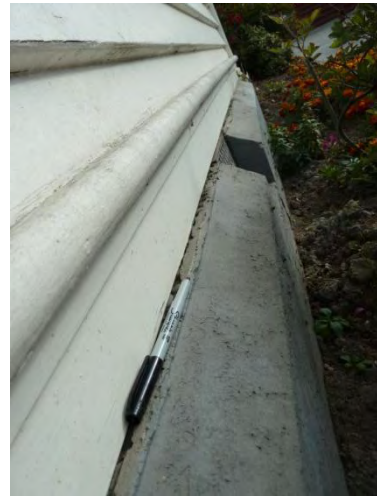
n) Foundation damage

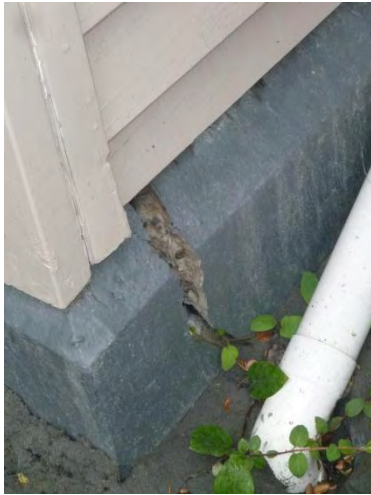
o) Foundation damage

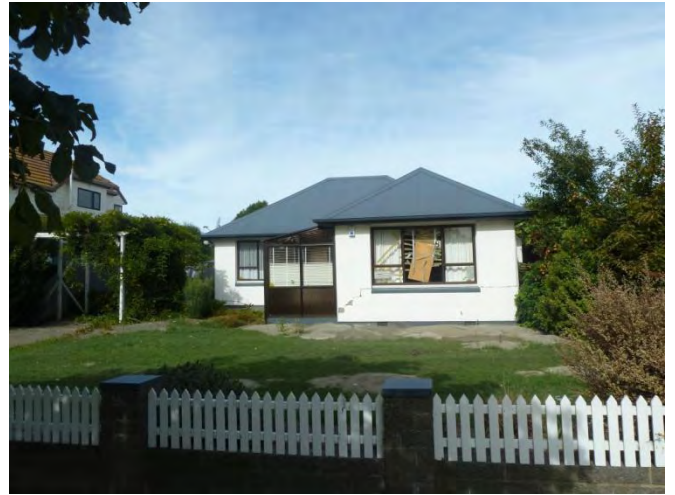
p) Liquefaction ejecta in many areas on lawn

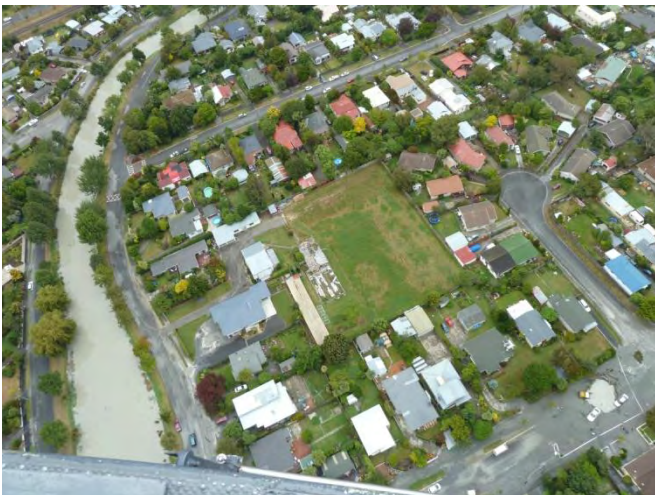
q) Aerial photo of Woolston showing road damage and liquefaction ejecta

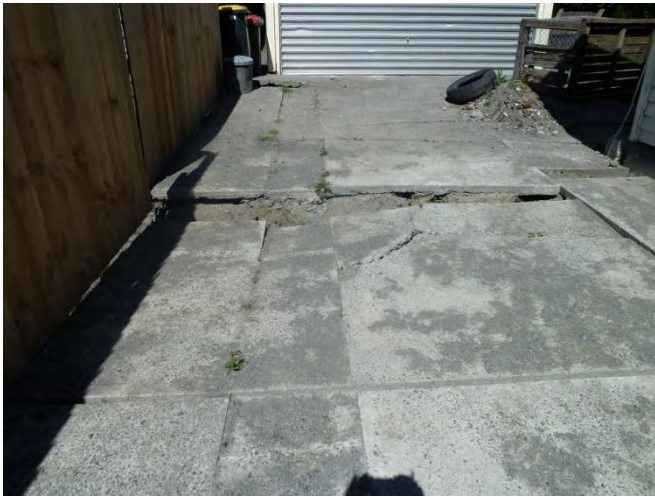
s) Undulating paving slabs

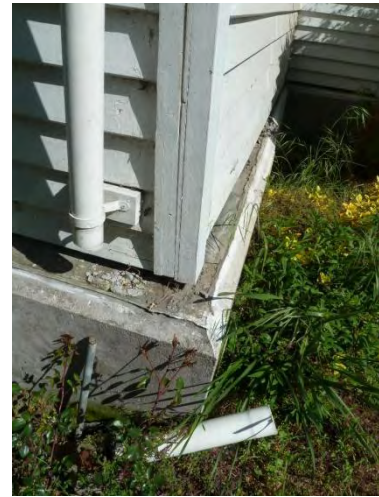
t) Foundation damage

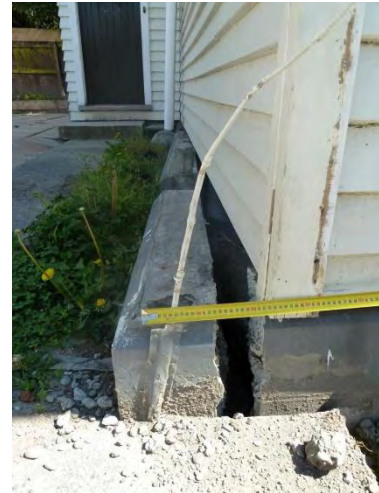
v) Foundation damage

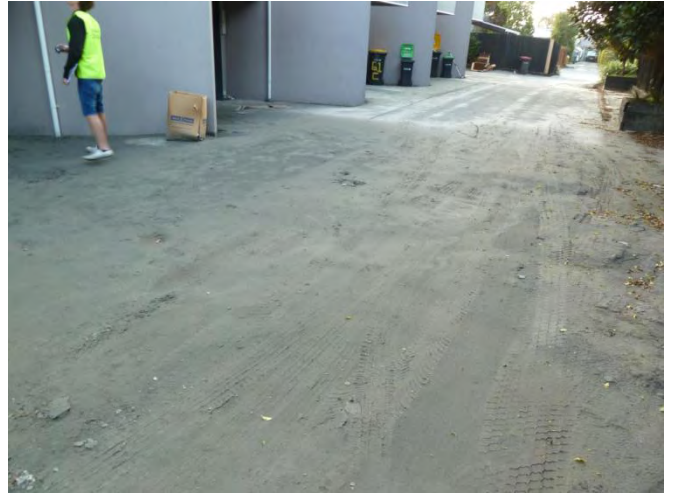
b) Liquefaction ejecta covering driveway

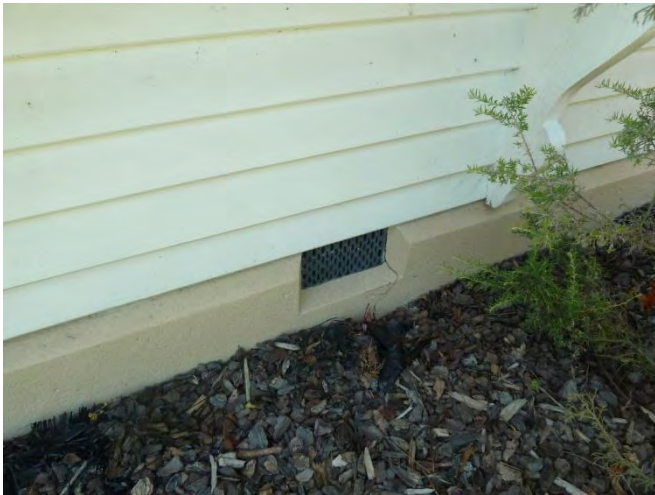
c) Foundation damage

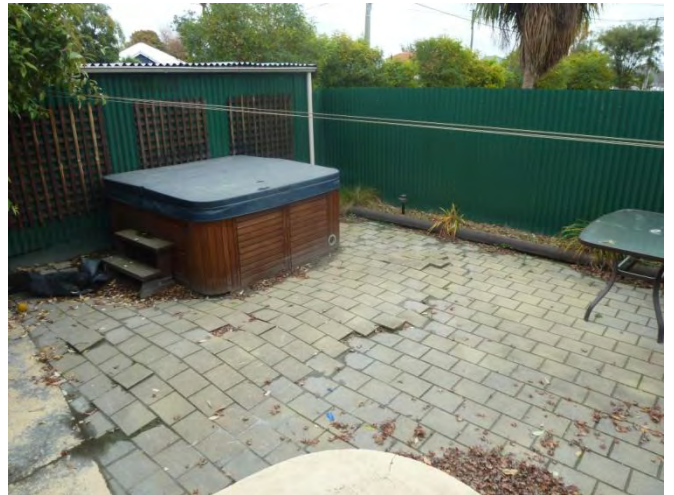
d) Undulations in paving area

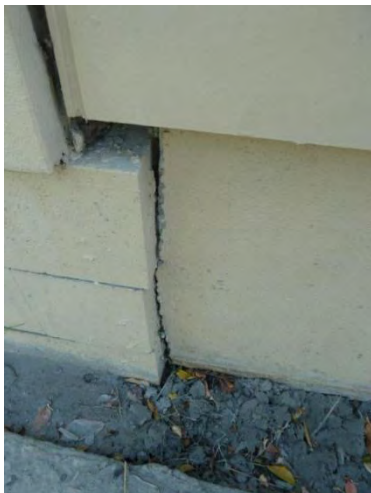
e) Foundation damage

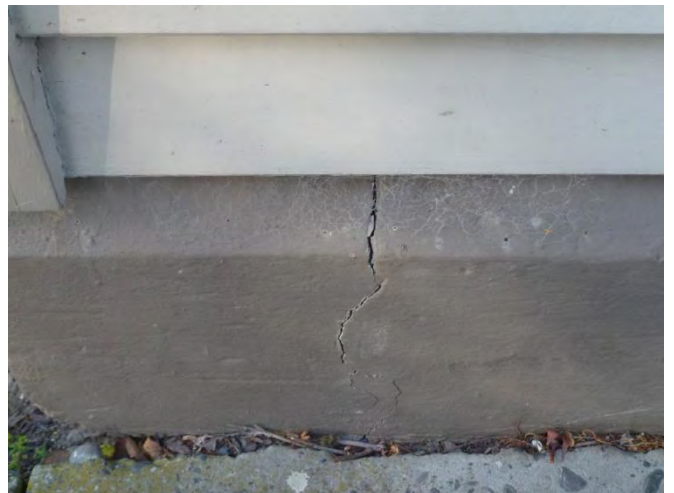
f) Foundation damage

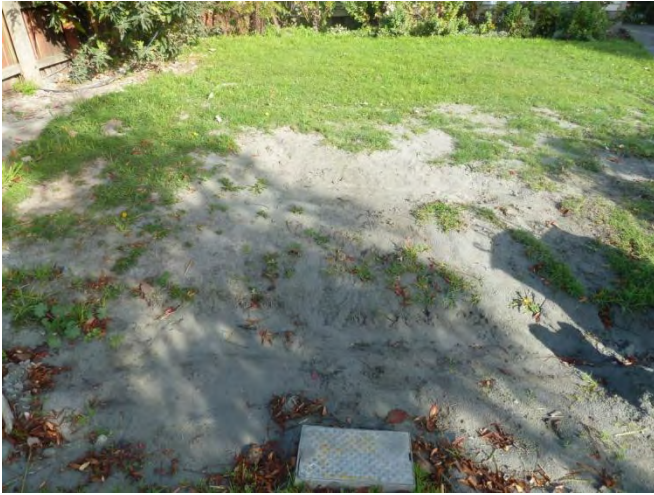
g) Liquefaction ejecta on lawn

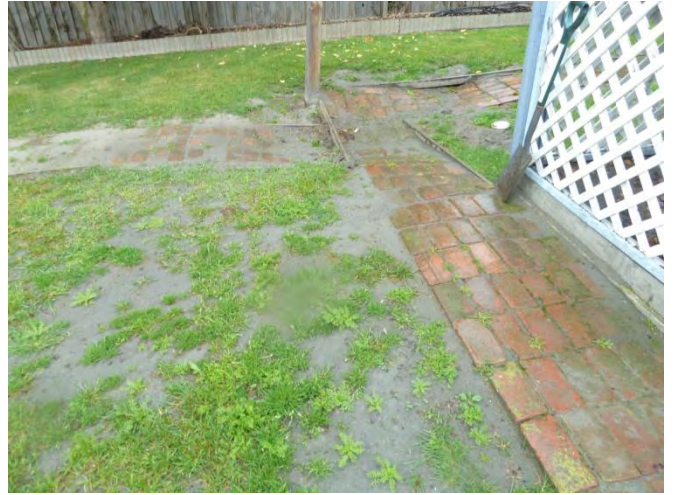
h) Undulations in lawn, liquefaction ejecta removed

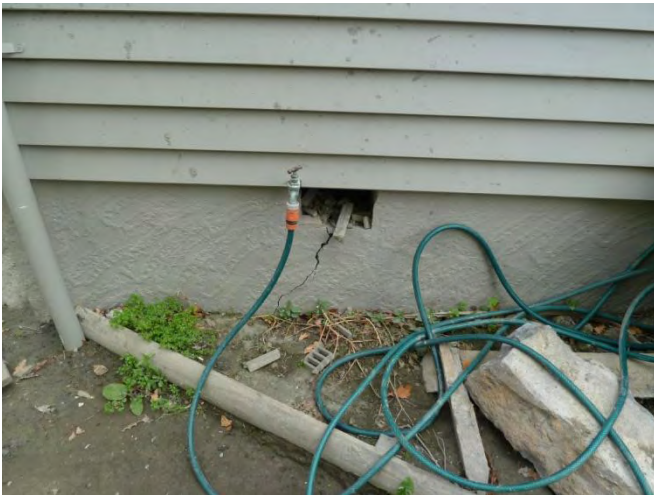
i) Foundation damage

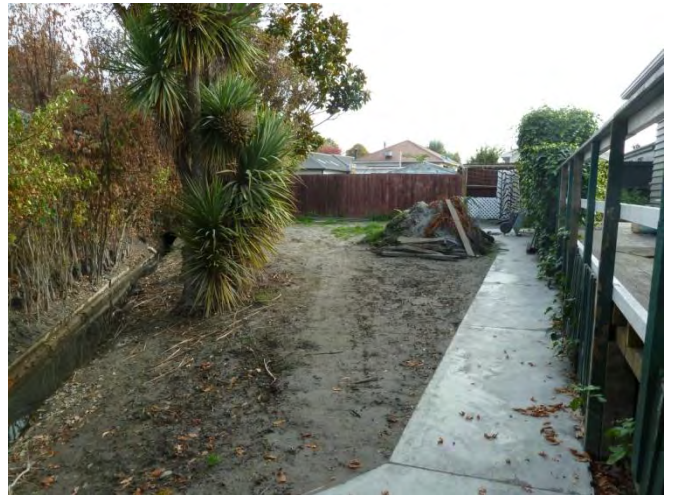
j) Liquefaction ejecta alongside culvert

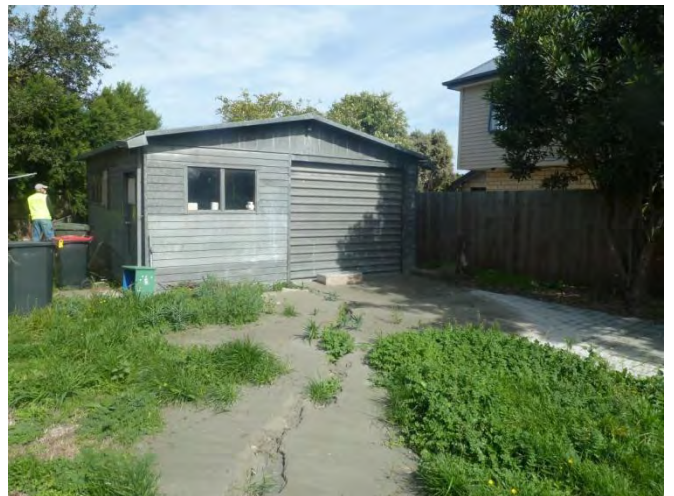
l) Liquefaction ejecta on lawn

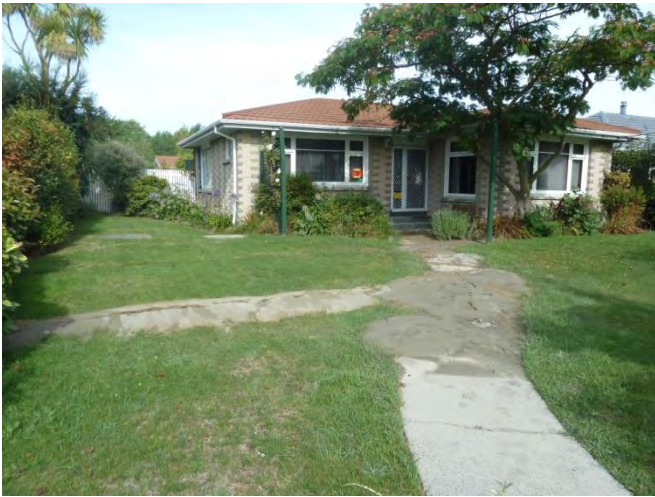
a) Isolated patches of liquefaction ejecta

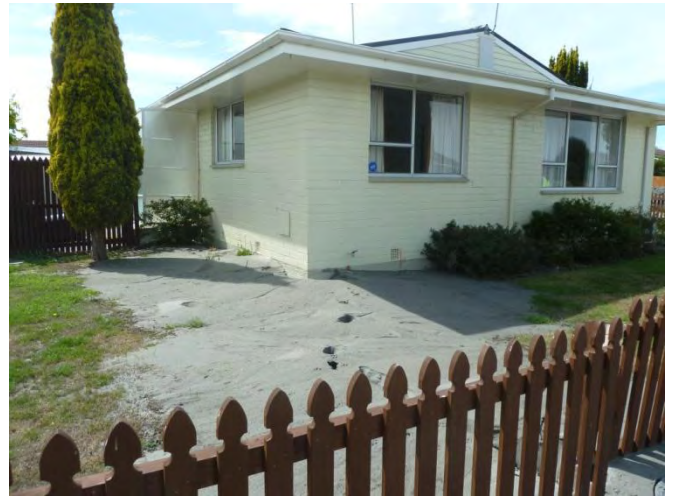
b) Large patch of liquefaction ejecta

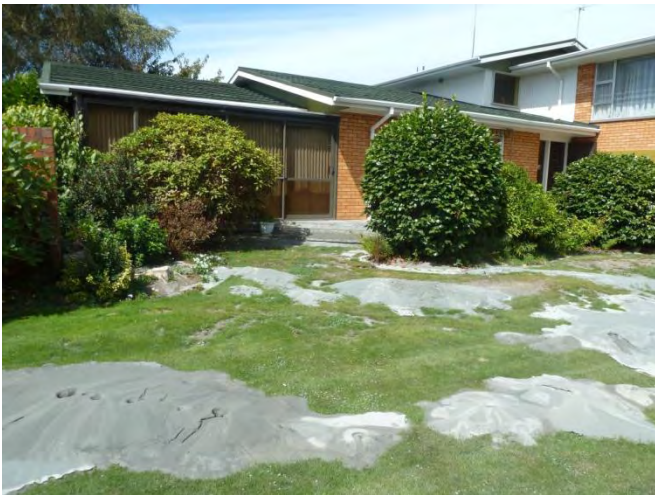
c) Numerous patches of liquefaction ejecta

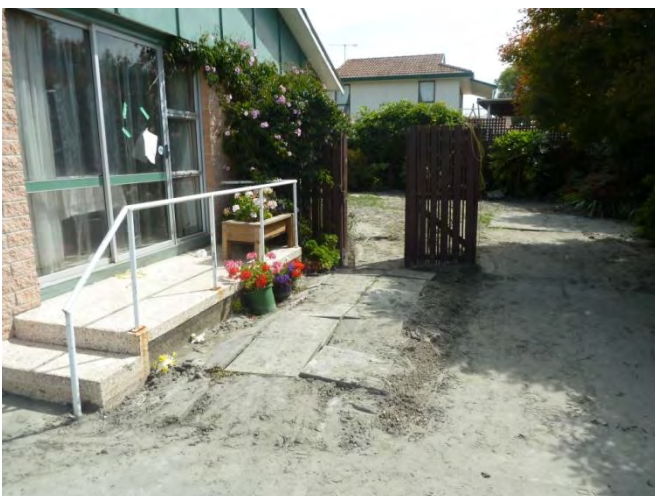
e) Undulating paving slabs with liquefaction ejecta

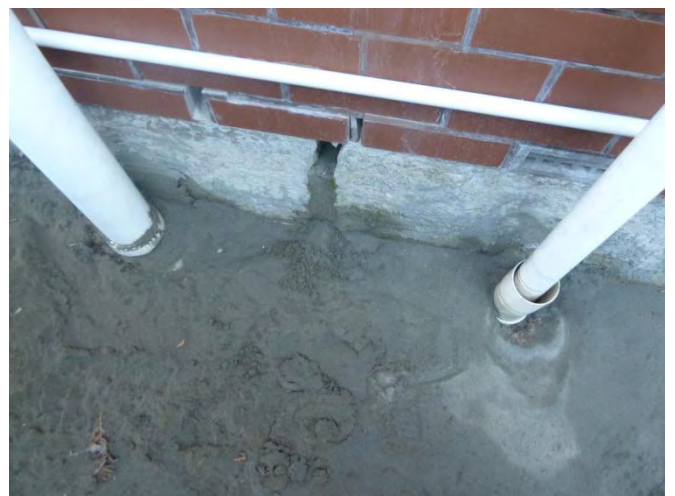
f) Foundation damage

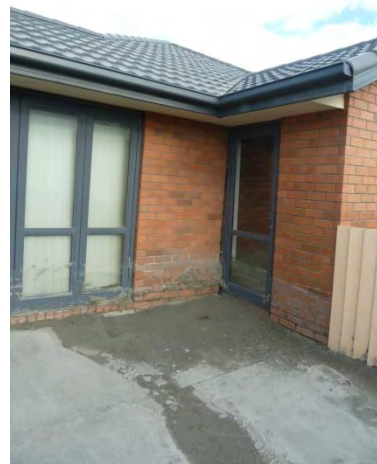
p) Outside of dwelling showing level liquefaction ejecta reached on brickwork and windows

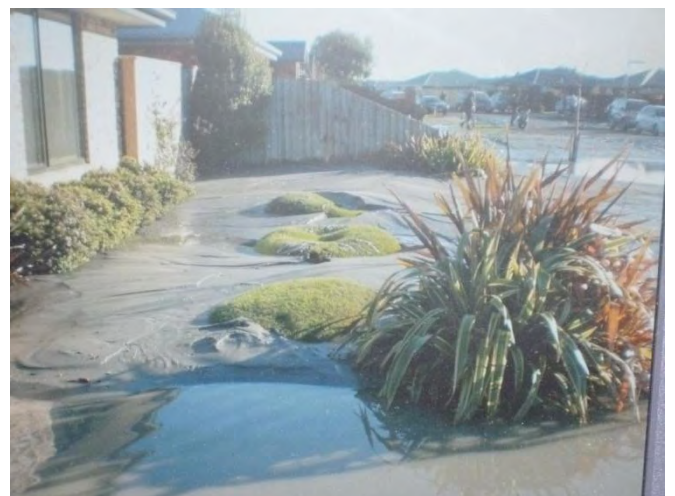
r) Large amounts of liquefaction ejecta
