## Appendix N: LSN Examples

## **N1 Introduction**

## **Typical Photographs of LSN Ranges**

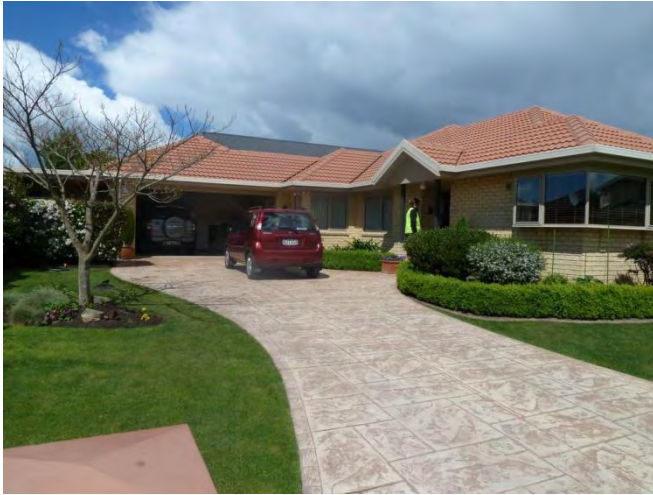
a) Even lawns and undamaged pavers

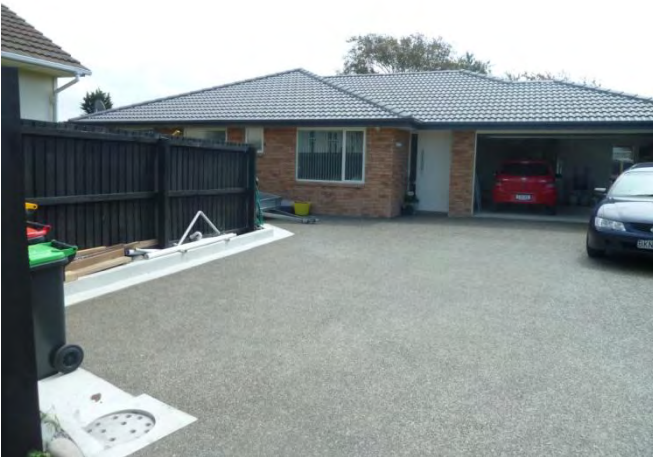
c) Undamaged concrete driveway and kerbing

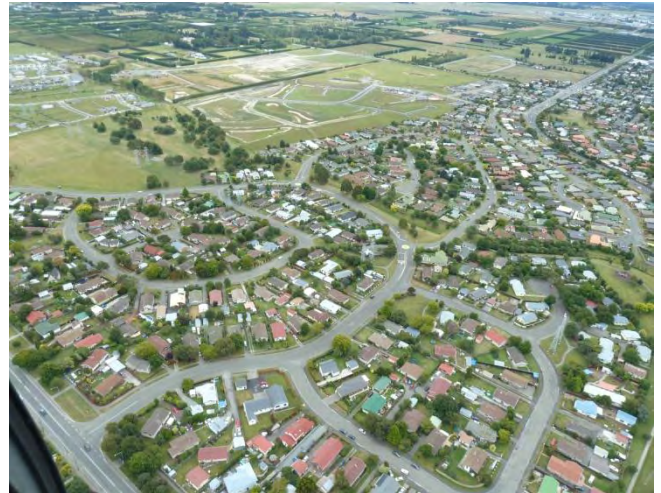
d) Aerial shot of Broomfield area showing no liquefaction ejecta on the roads or Broomfield Common

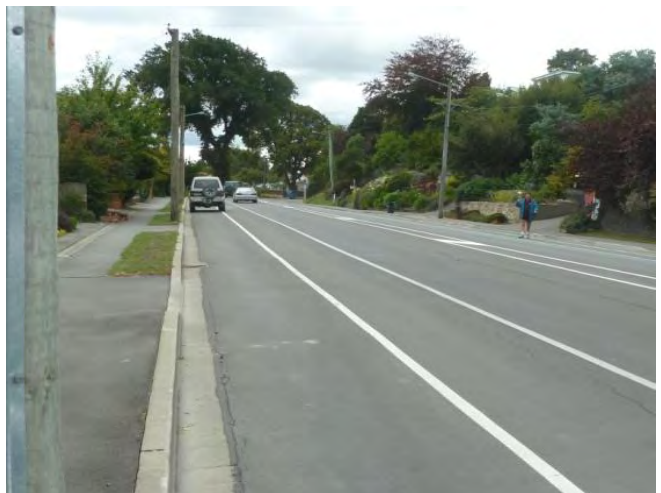
f) View of Centaurus Road with little damage

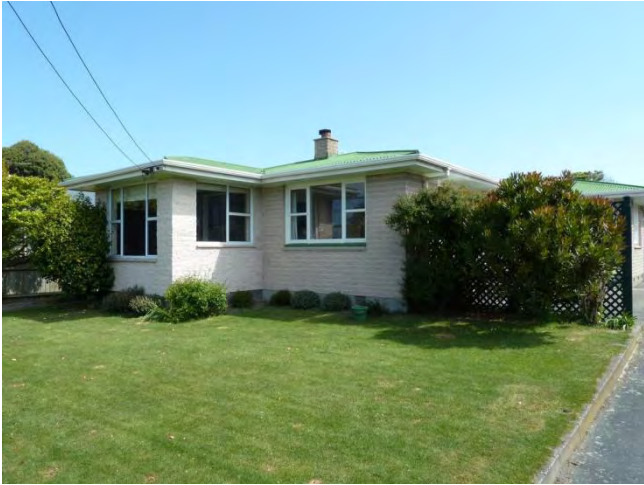
g) Flat lawn

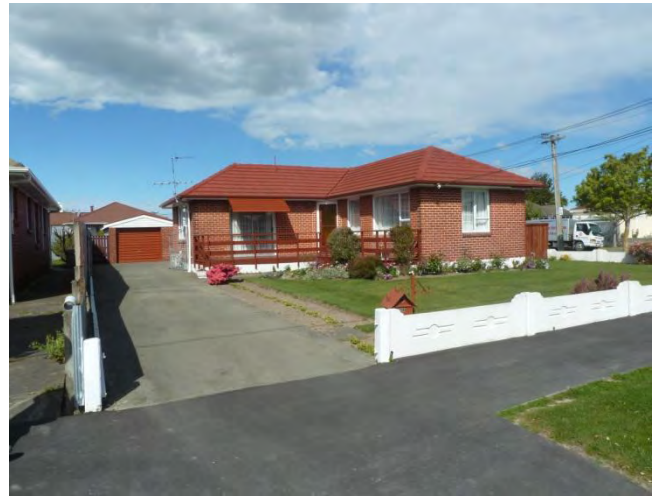
h) Slightly undulating lawn and driveway

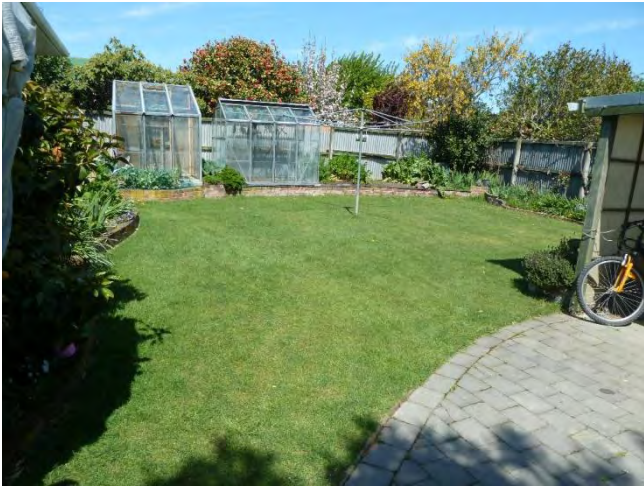
i) Slightly undulating lawn

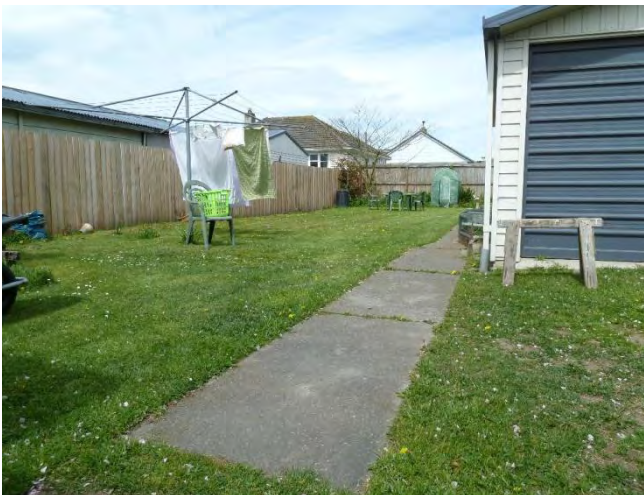
k) Undulating lawn

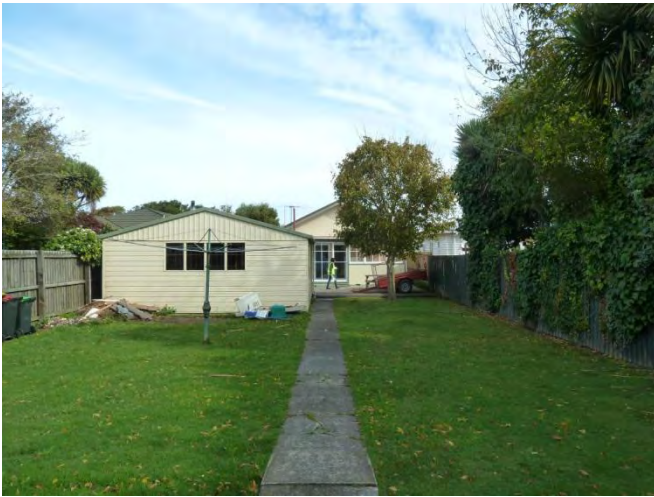
a) Undulating lawn

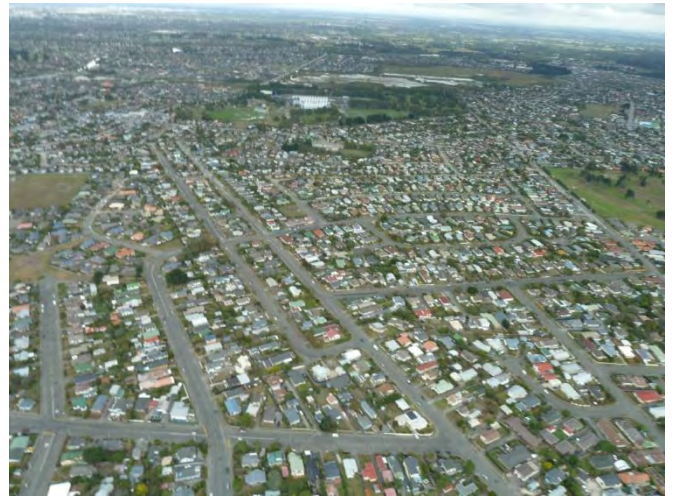
b) Aerial photo of North New Brighton showing little damage

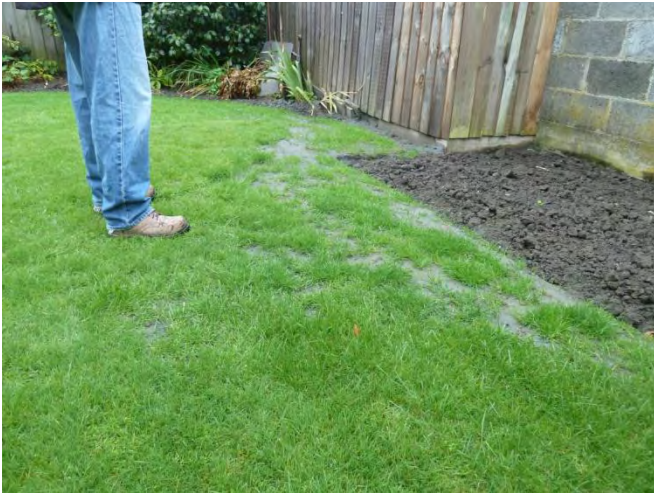
c) Isolated area of liquefaction ejecta on lawn

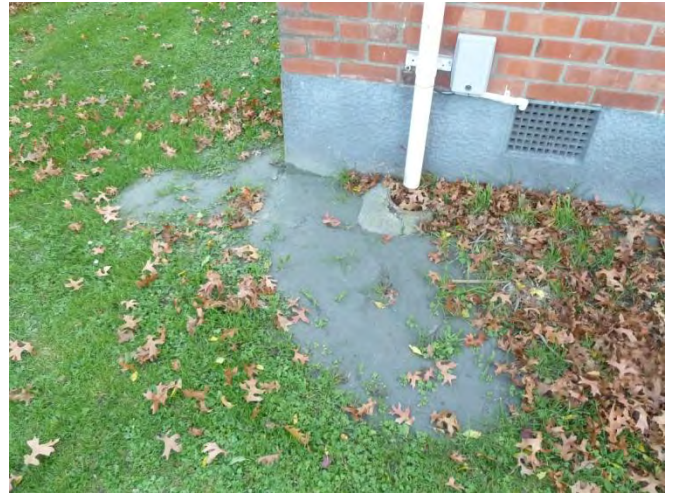
d) Isolated area of liquefaction ejecta on lawn

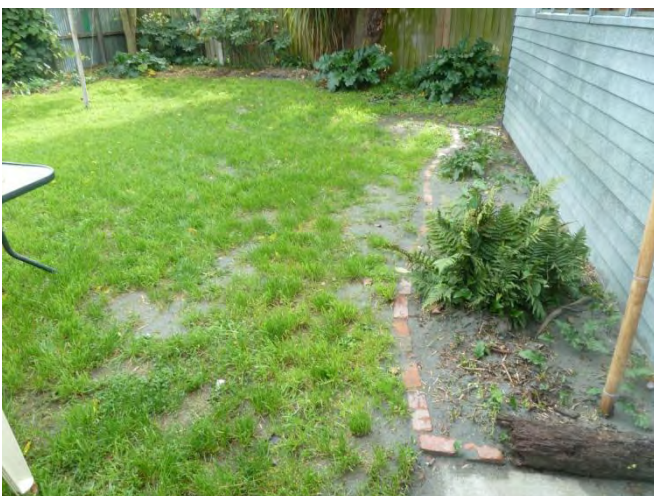
e) Isolated area of liquefaction ejecta on lawn

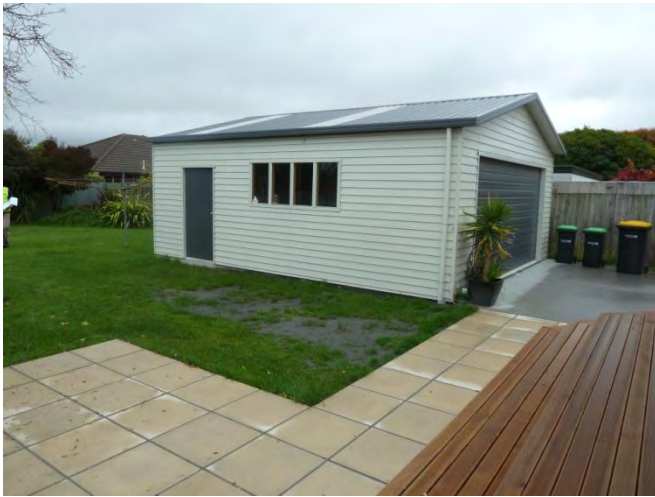
g) Liquefaction ejecta on lawn

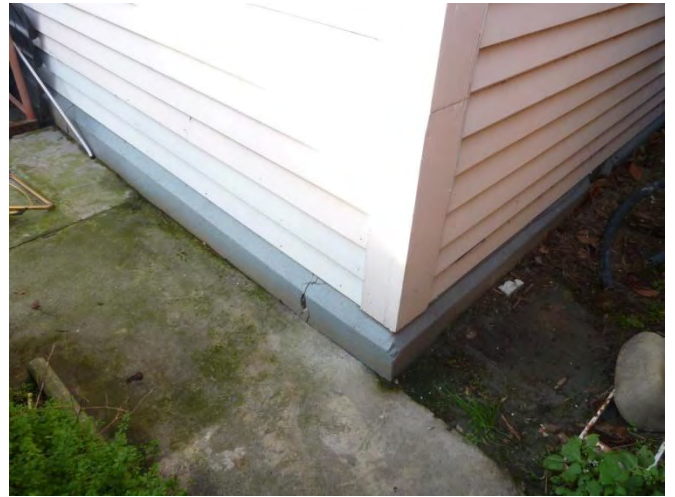
h) Foundation damage

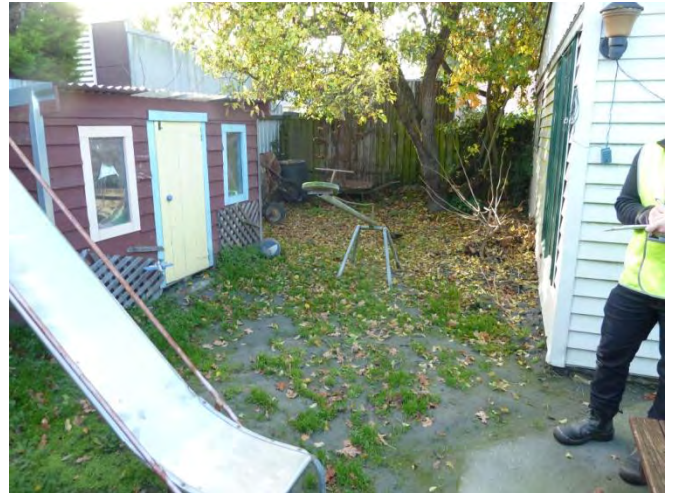
j) Liquefaction ejecta on lawn

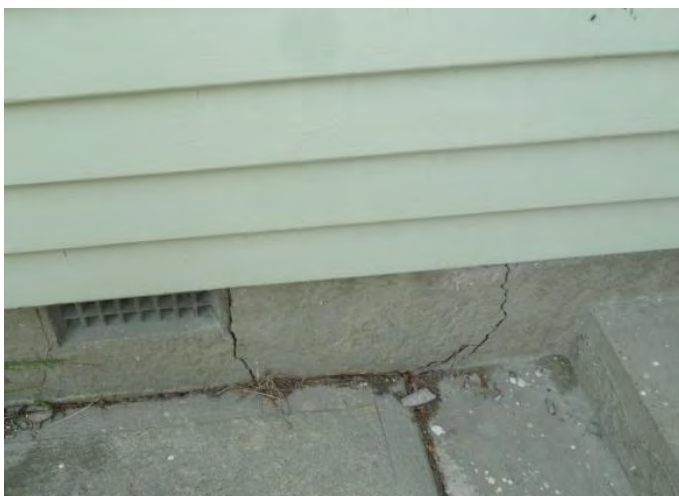
k) Foundation damage

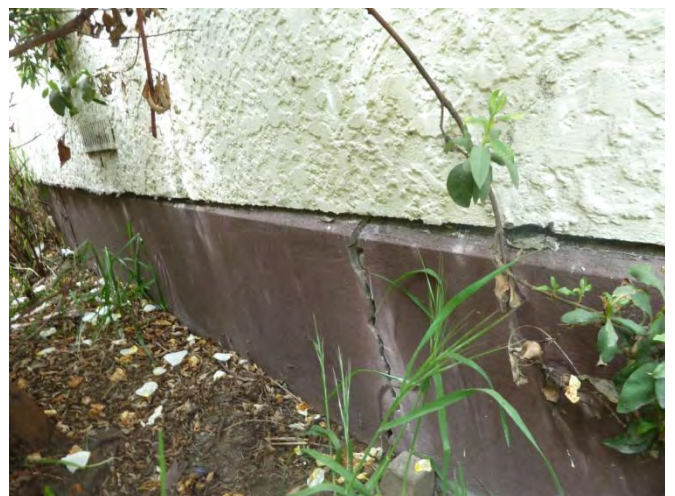
l) Foundation damage

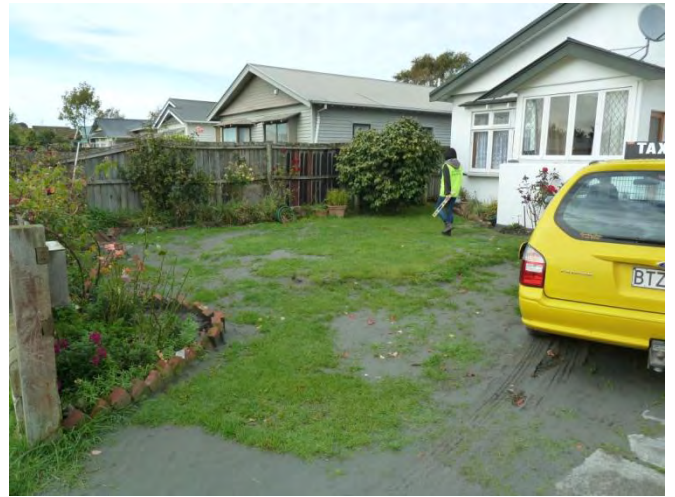
n) Liquefaction ejecta on lawn

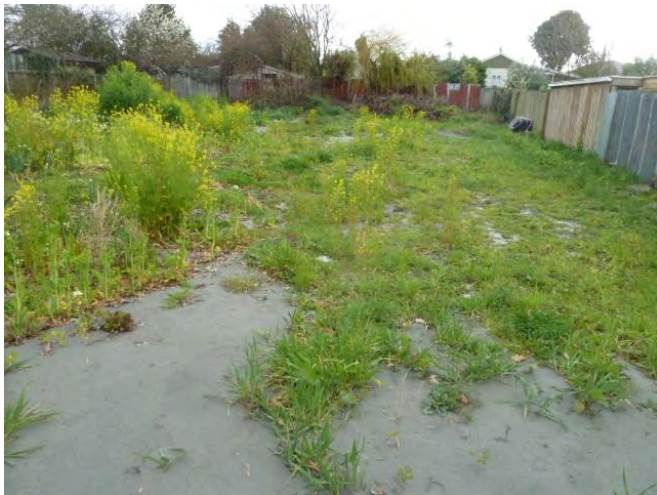
o) Liquefaction ejecta on lawn

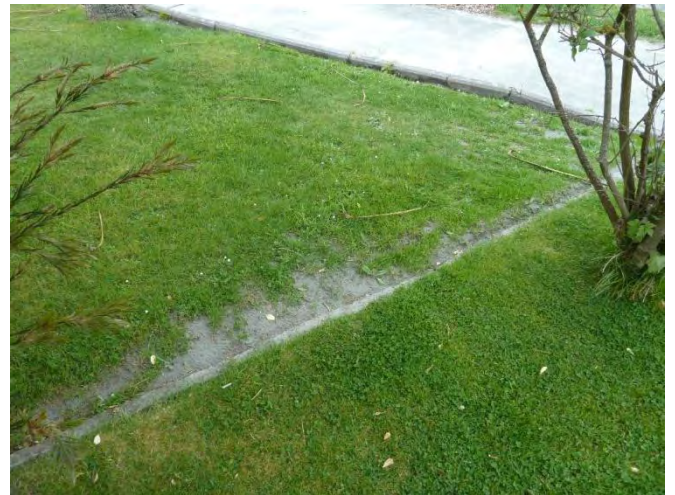
p) Liquefaction ejecta trapped under lawn

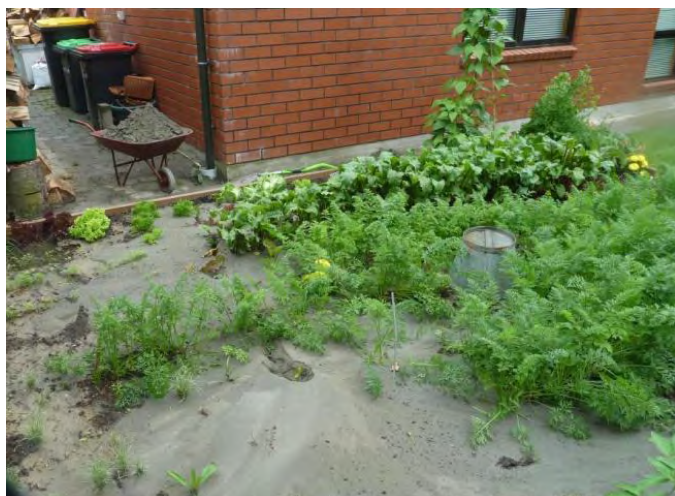
q) Liquefaction ejecta in planter

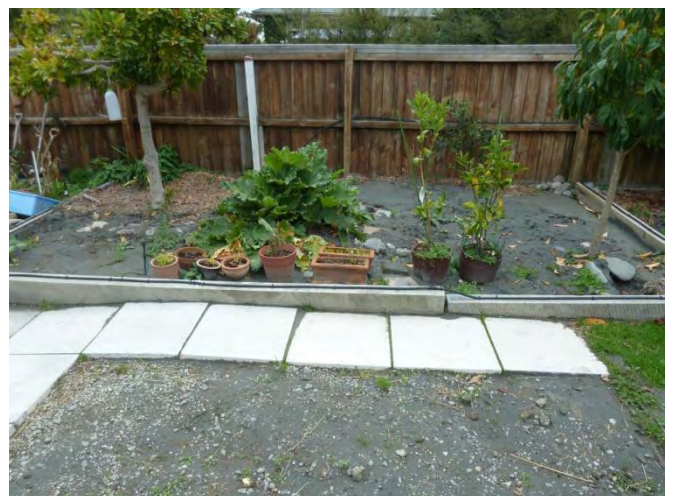
r) Liquefaction ejecta in planter with undulating pavers

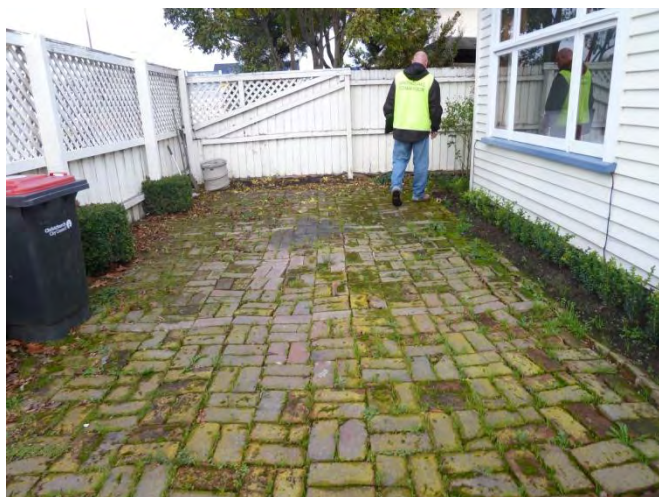
s) Undulating brick paving

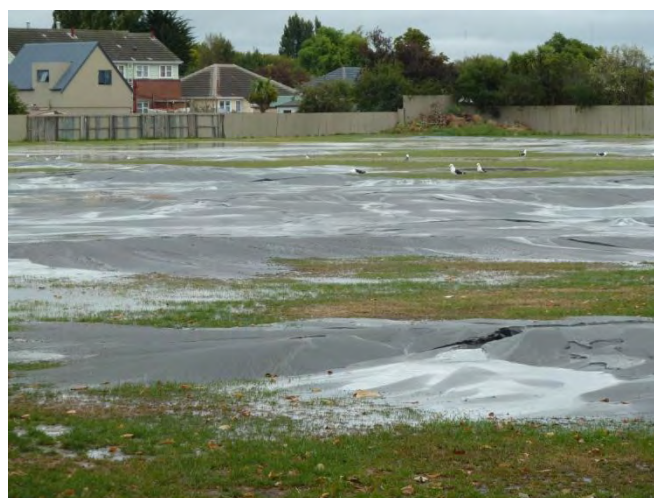
x) Liquefaction ejecta on Shirley Boys High School lawns

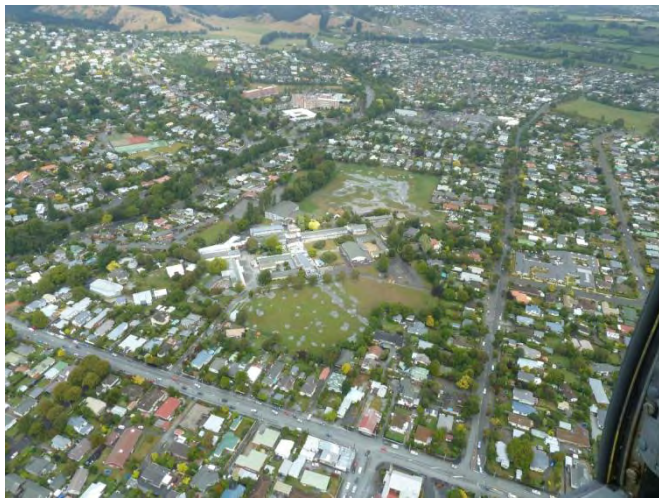
a) Aerial photo of liquefaction ejecta at Cashmere High School

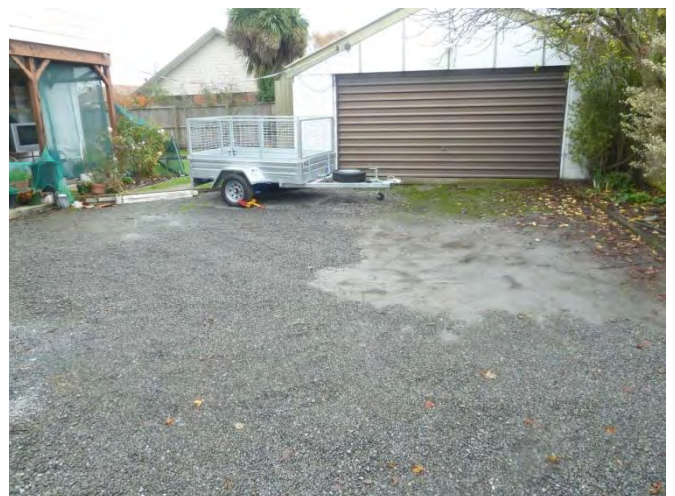
f) Isolated area of liquefaction ejecta

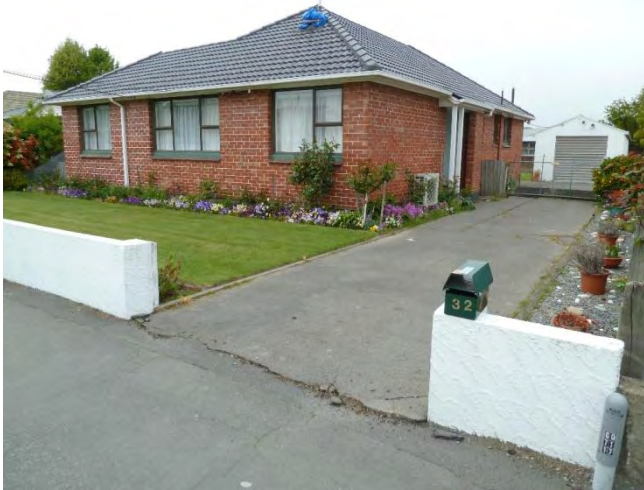
g) Damage to asphalt

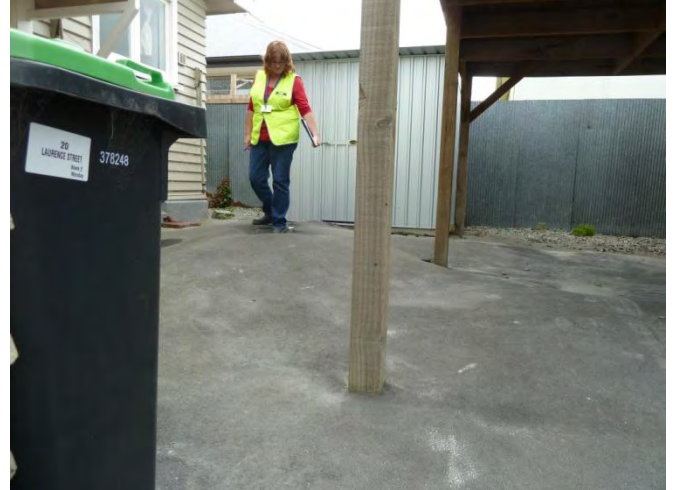
h) Liquefaction ejecta trapped below asphalt

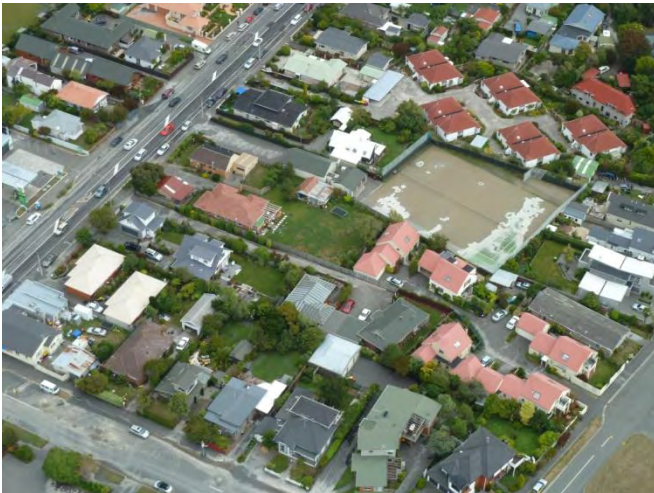
i) Aerial shot of Redcliffs with liquefaction ejecta

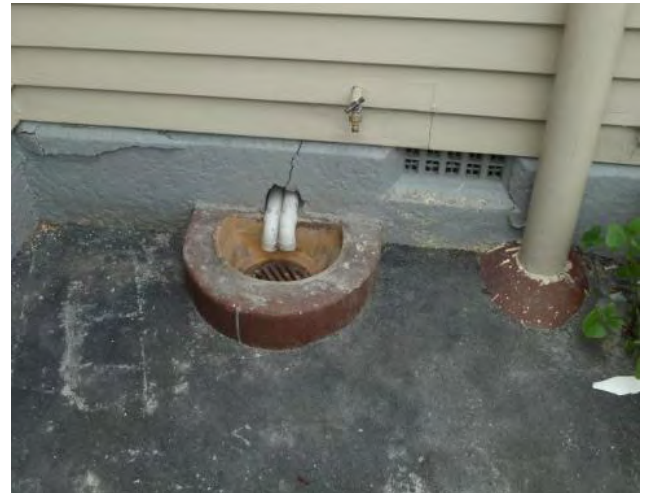
j) Foundation damage

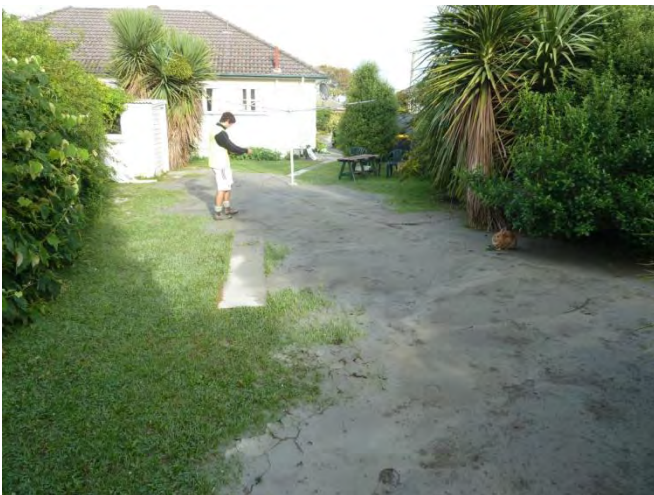
k) Liquefaction ejecta on lawn

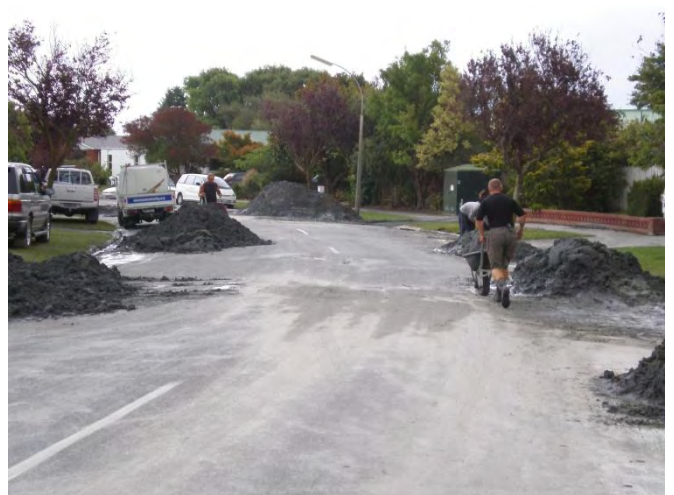
l) Liquefaction ejecta in piles on road

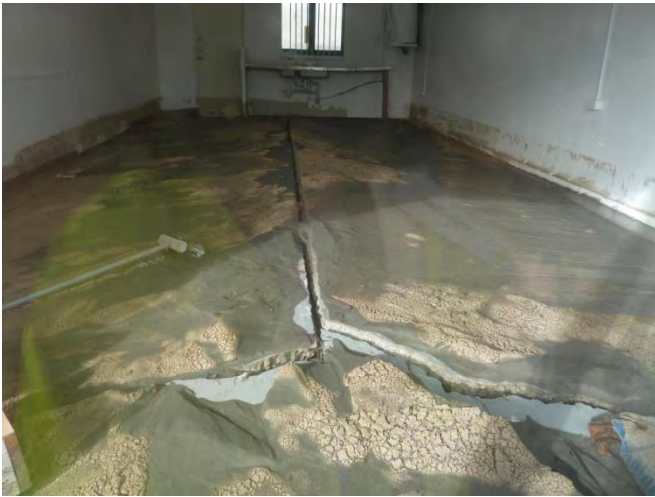
m) Foundation damage

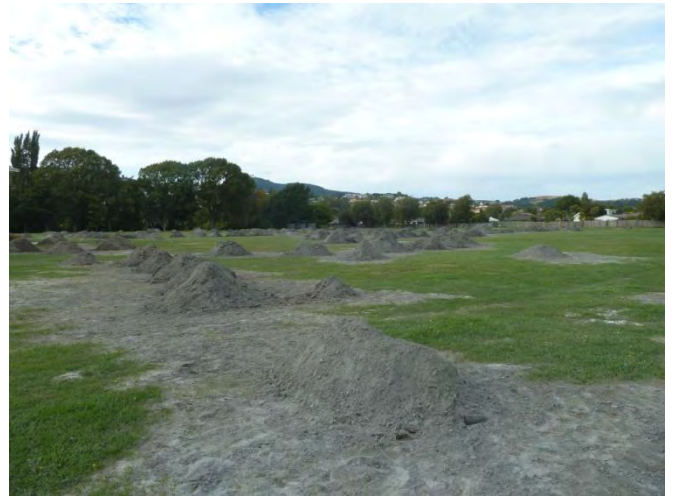
n) Liquefaction ejecta piled on Cashmere High School lawns

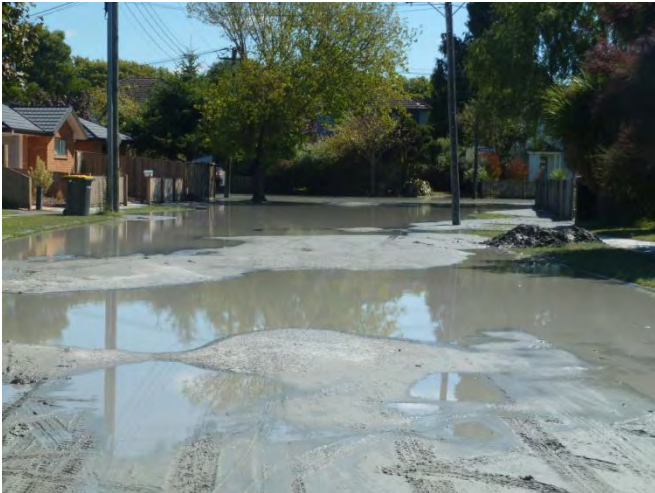
o) Road damage on Orontes Street with ponding water

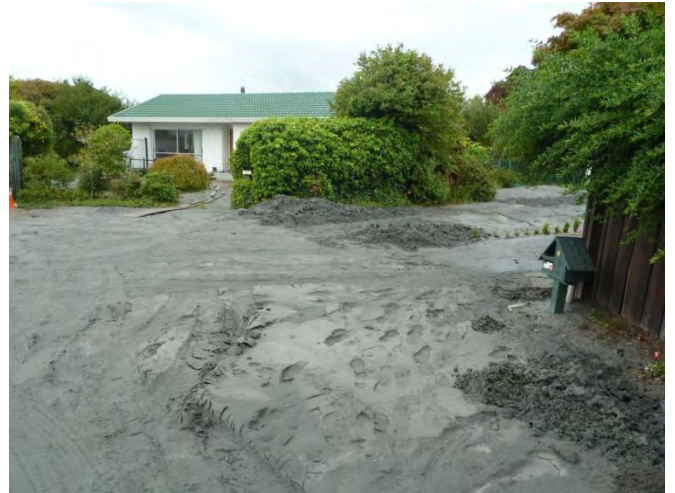
p) Liquefaction ejecta covering turning circle in Chale Lane

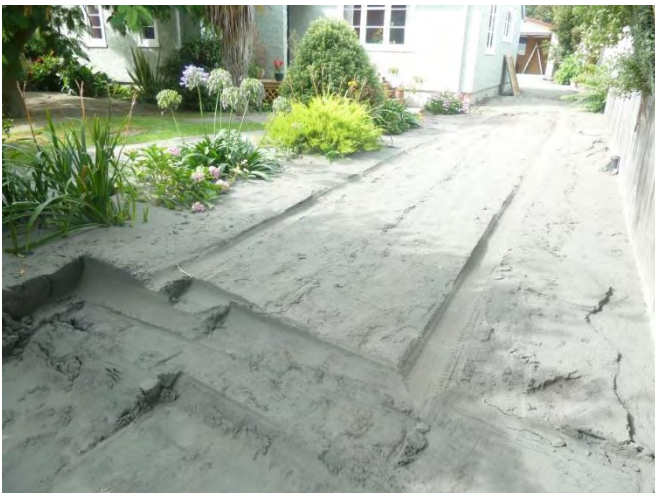
q) Liquefaction ejecta on driveway

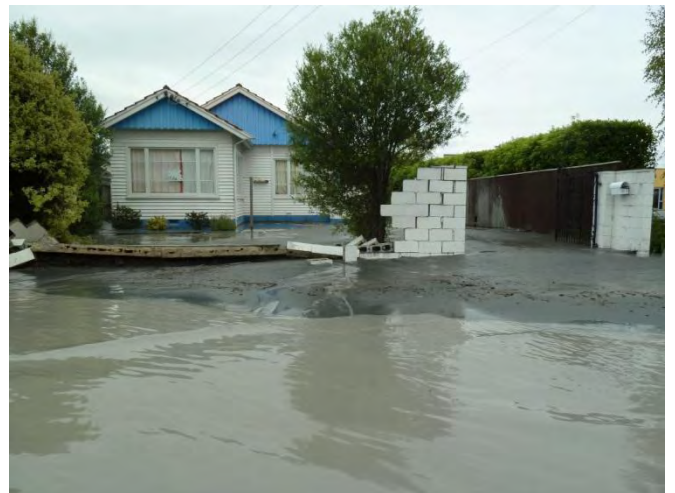
r) Liquefaction ejecta and ponding water

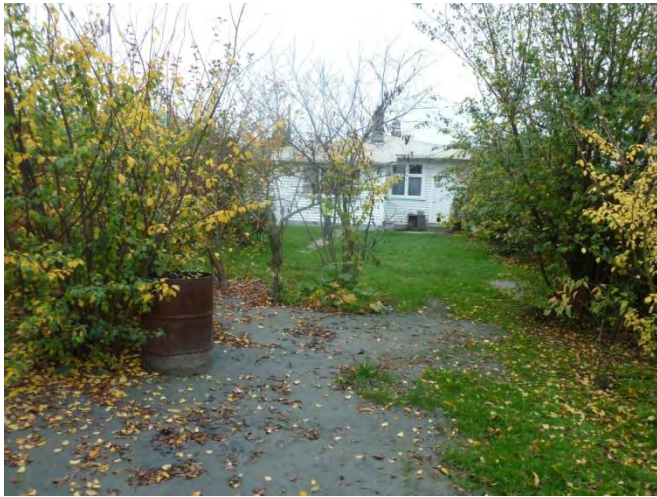
g) Liquefaction ejecta on lawn

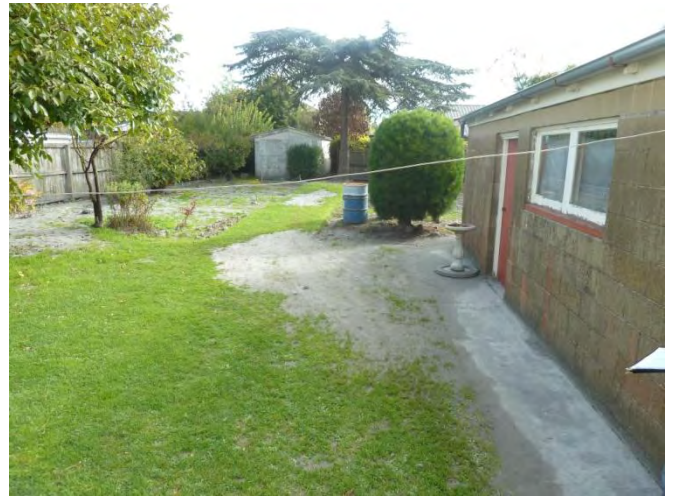
h) Liquefaction ejecta in many places on lawn

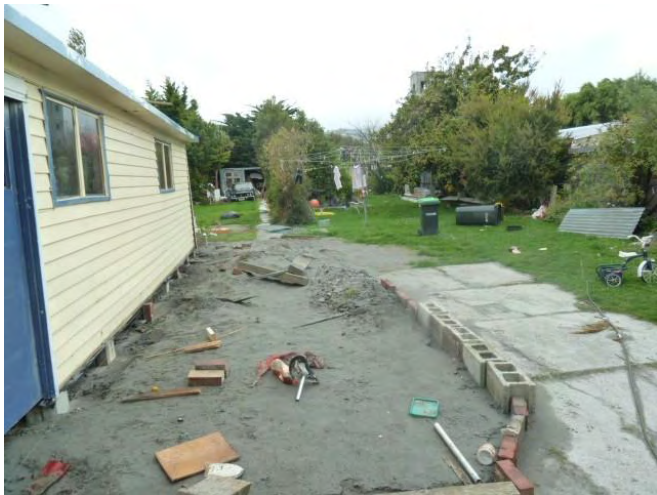
i) Large area of liquefaction ejecta on lawn

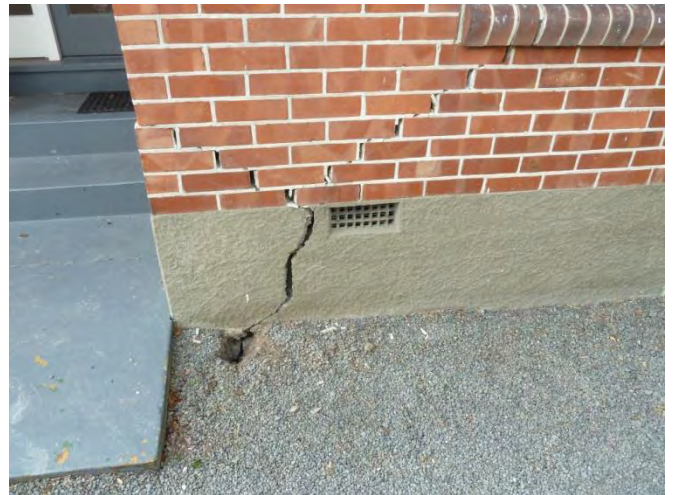
j) Foundation and brickwork damage

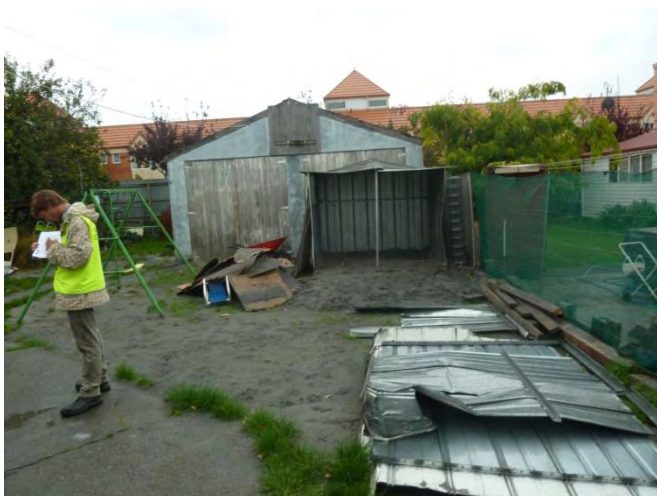
k) Large area of liquefaction ejecta on lawn

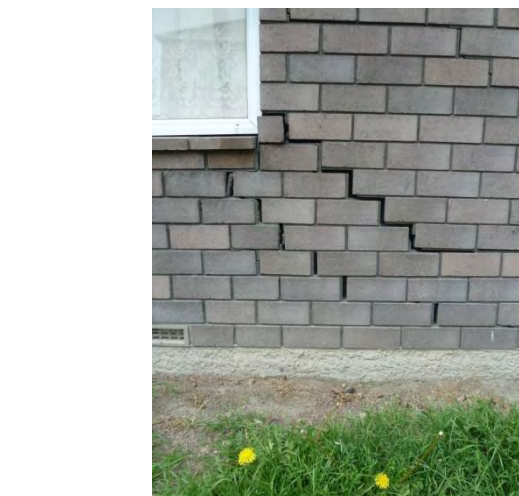
l) Brickwork damage

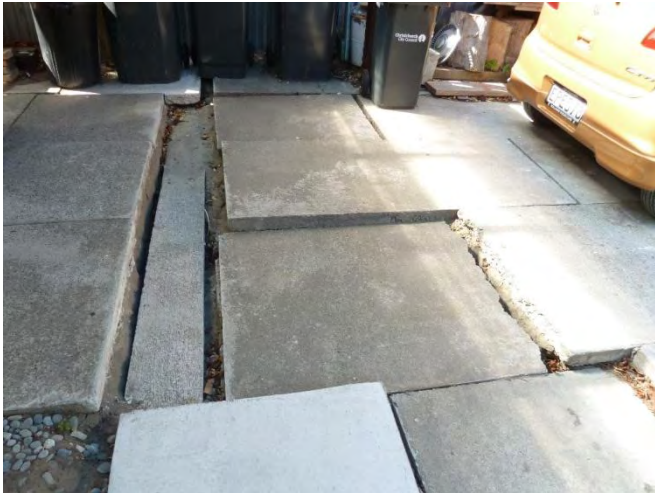
u) Undulating paving slabs

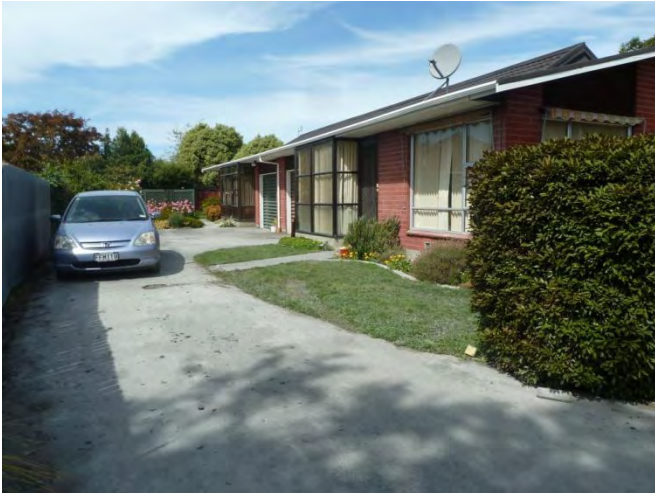
a) Undulations in lawn

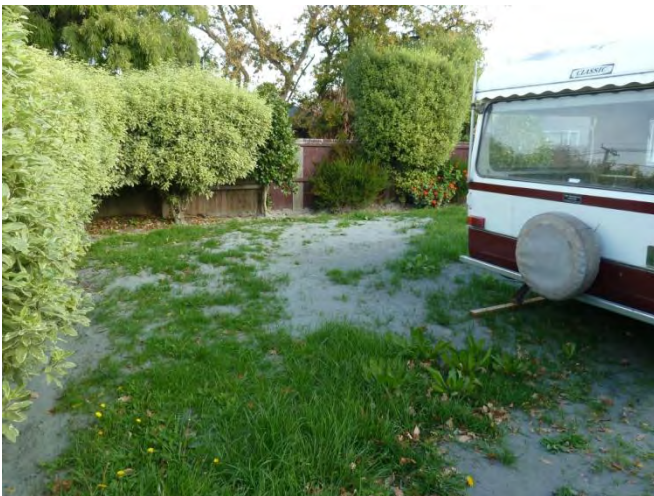
k) Liquefaction ejecta on lawn

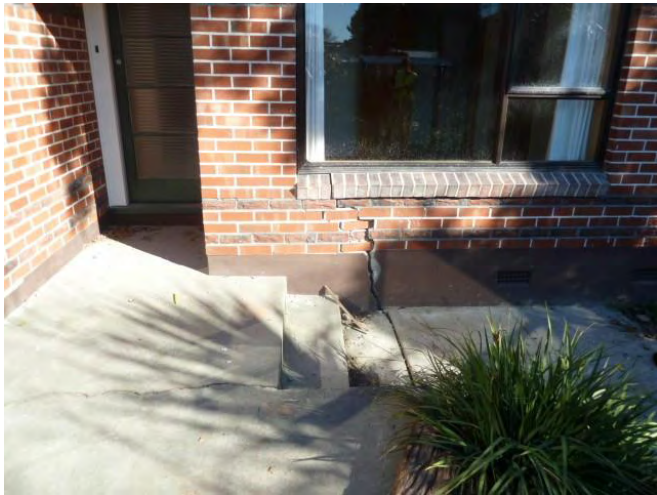
m) Foundation damage

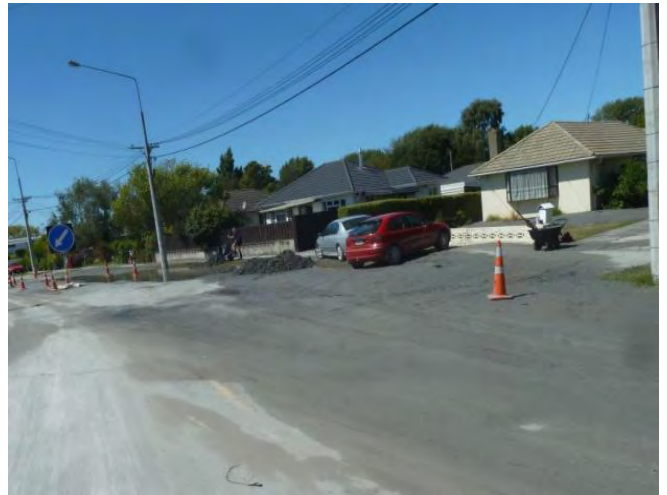
n) Liquefaction ejecta on New Brighton Road

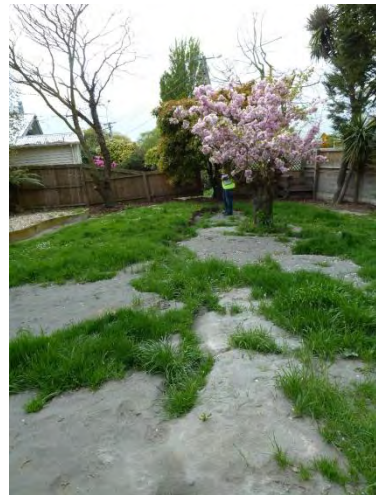
d) Numerous patches of liquefaction ejecta

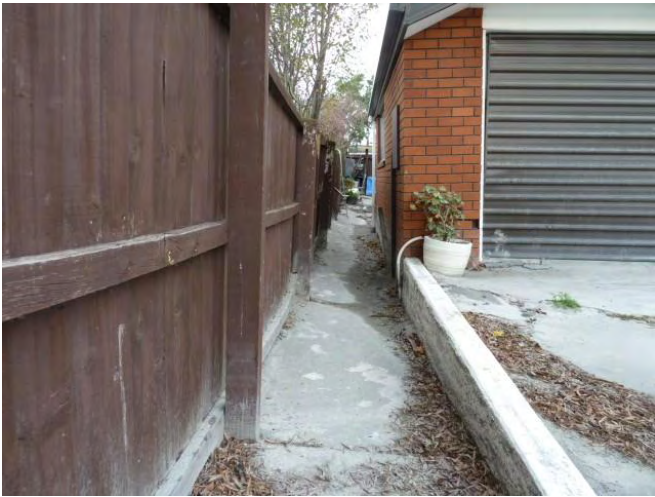
g) Tilting paving slabs as dwelling settled

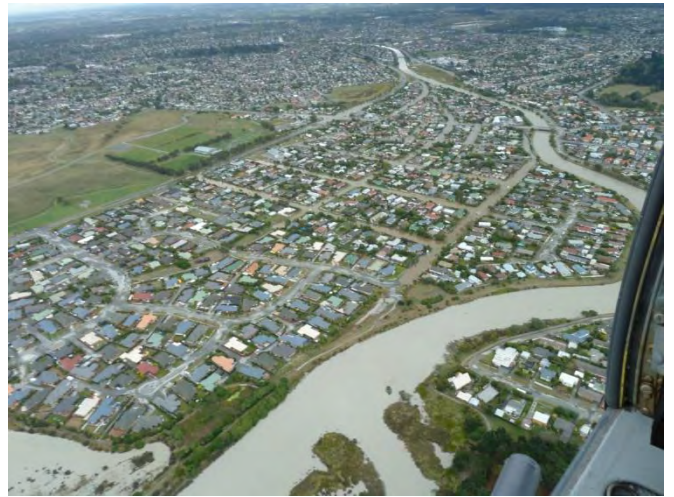
h) Aerial view of Bexley with flooded roads and large amounts of liquefaction ejecta

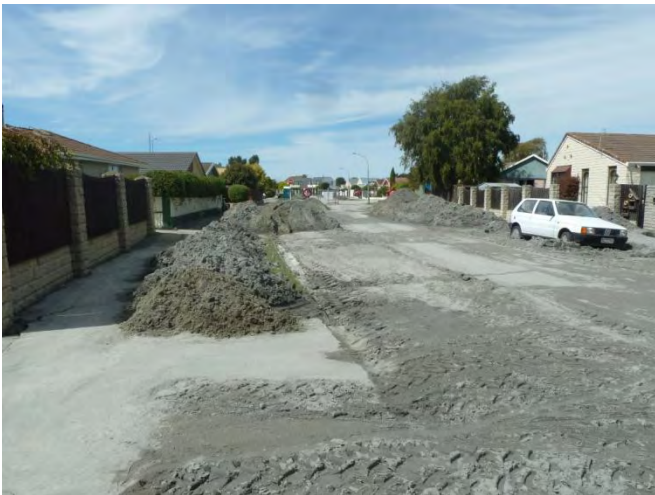
i) Liquefaction ejecta piles along Androssan Street

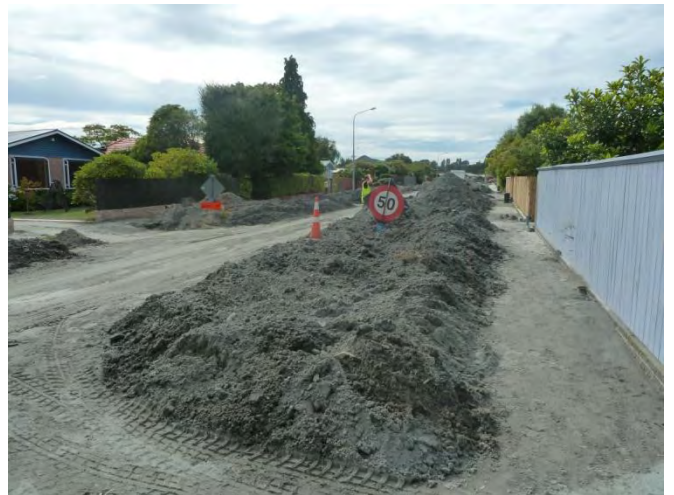
j) Liquefaction ejecta piles along Avonside Drive

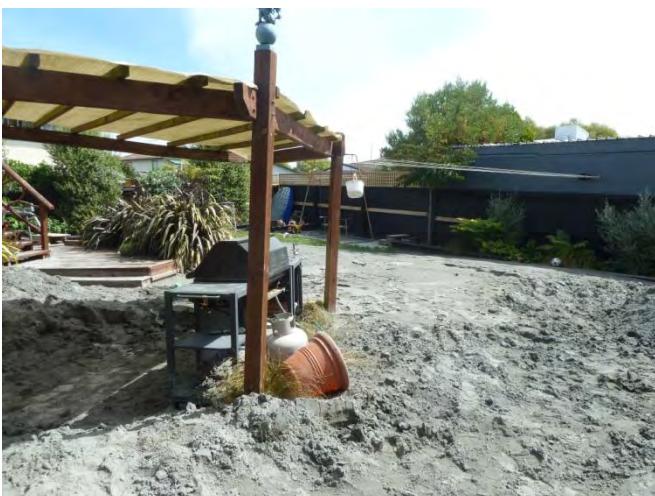
k) Liquefaction ejecta around property

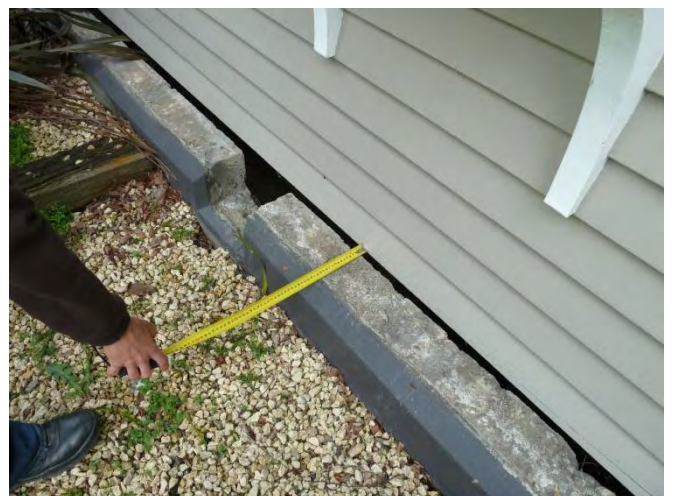
l) Foundation damage

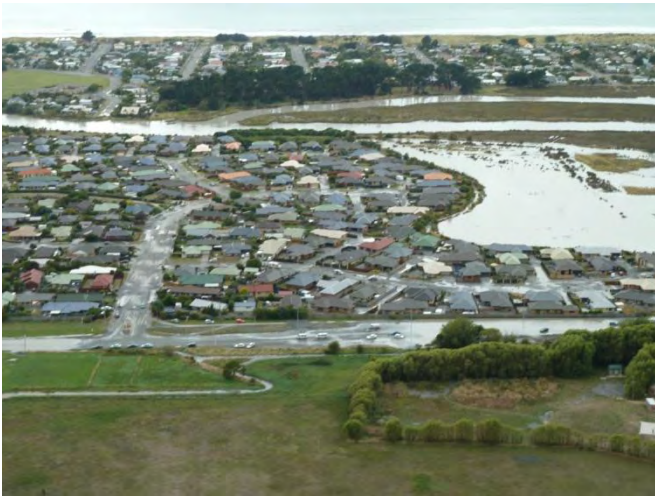
m) Aerial photo showing liquefaction ejecta on Seabreeze Close

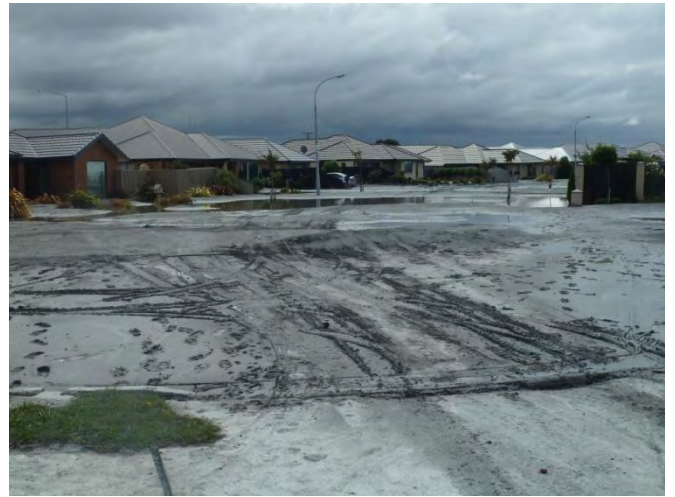
n) Liquefaction ejecta in turning circle of Seabreeze Close

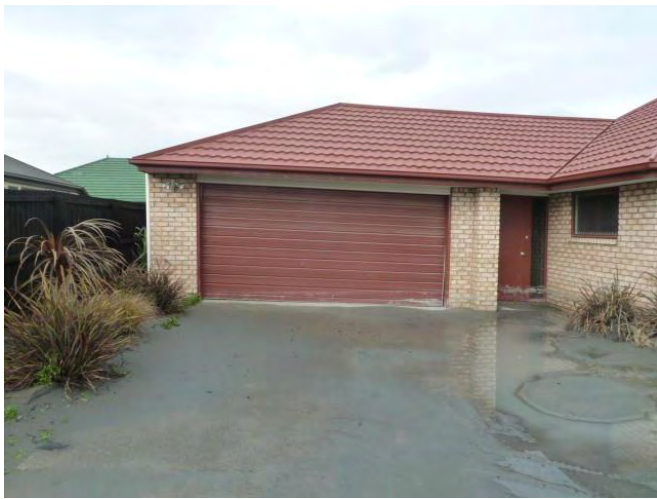
s) Large amounts of liquefaction ejecta and tilting dwelling

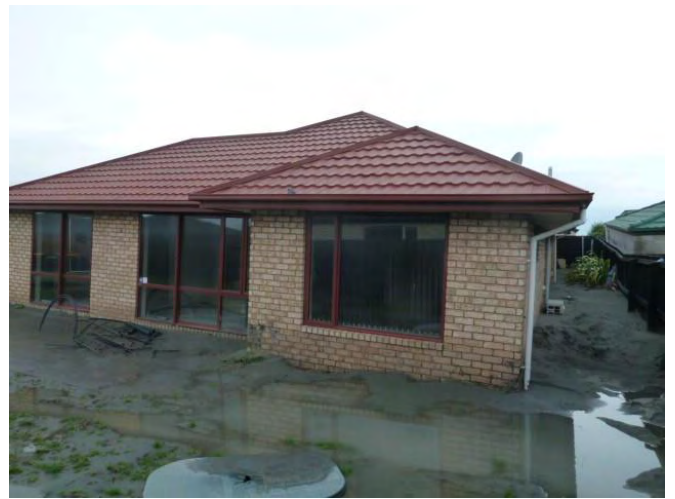
t) Large amounts of liquefaction ejecta around property

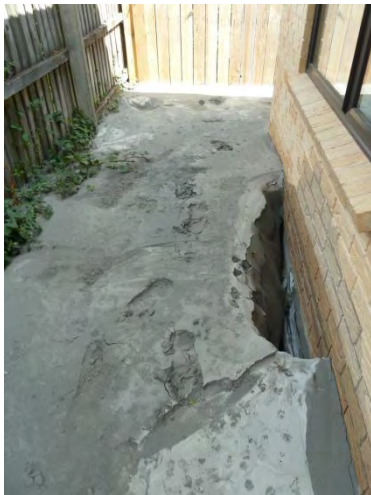
u) Large amounts of liquefaction ejecta

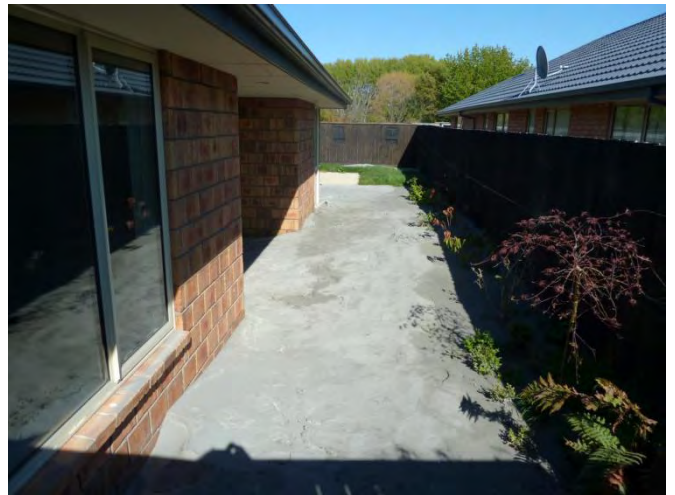
v) Large amounts of liquefaction ejecta

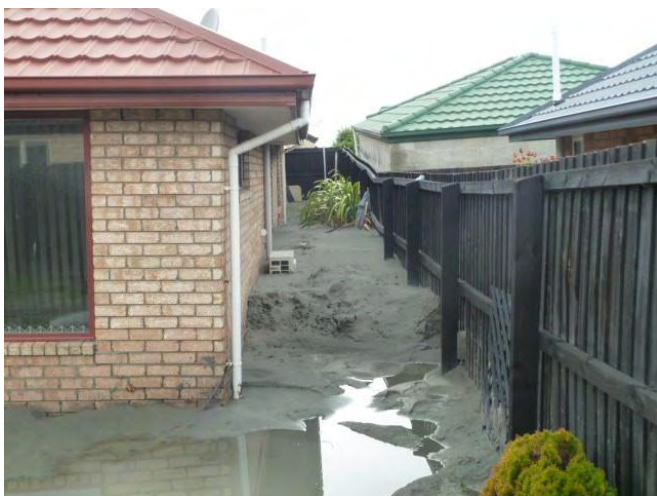
w) Large amounts of liquefaction ejecta

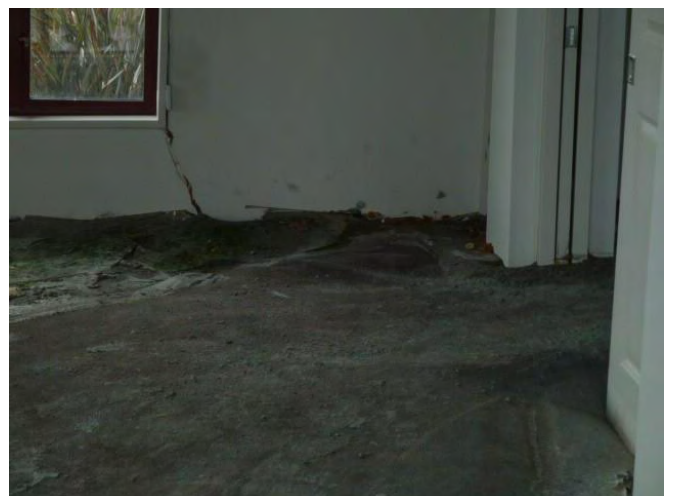
x) Large amounts of liquefaction ejecta inside dwelling
